PROPERTY INSPECTION REPORT

Tony Burk
OHI.2019004151 expr. 8/1/2022
Accutech Home Inspections

123 Main St
Inspection Prepared For: Owner Homer
Agent:

Date of Inspection: 3/12/21
Age of House: 1895 Size: 1148
Weather: Overcast

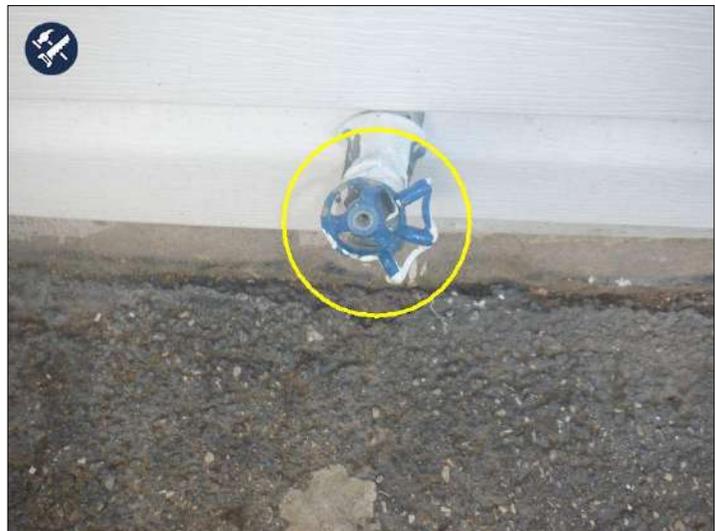
Page 30 Item: 6	Water Spigots Conditions	• Repair: The left exterior water spigot handle was broken – recommend repair.
-----------------	--------------------------	--

Repair: The left exterior water spigot handle was broken – recommend repair.

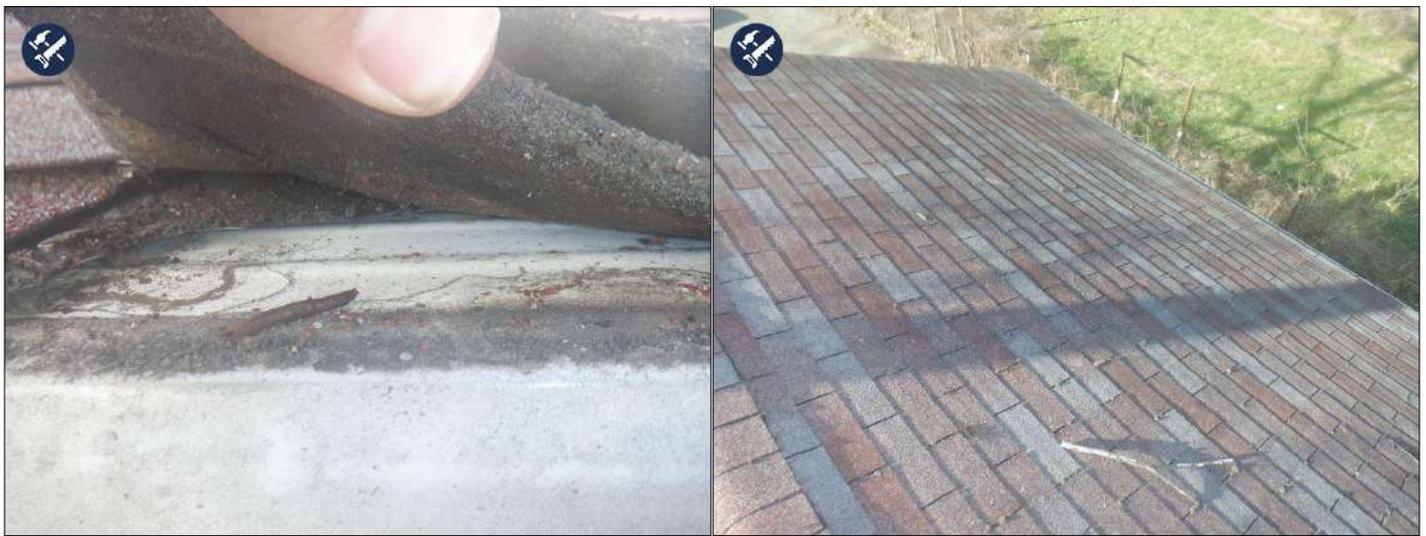
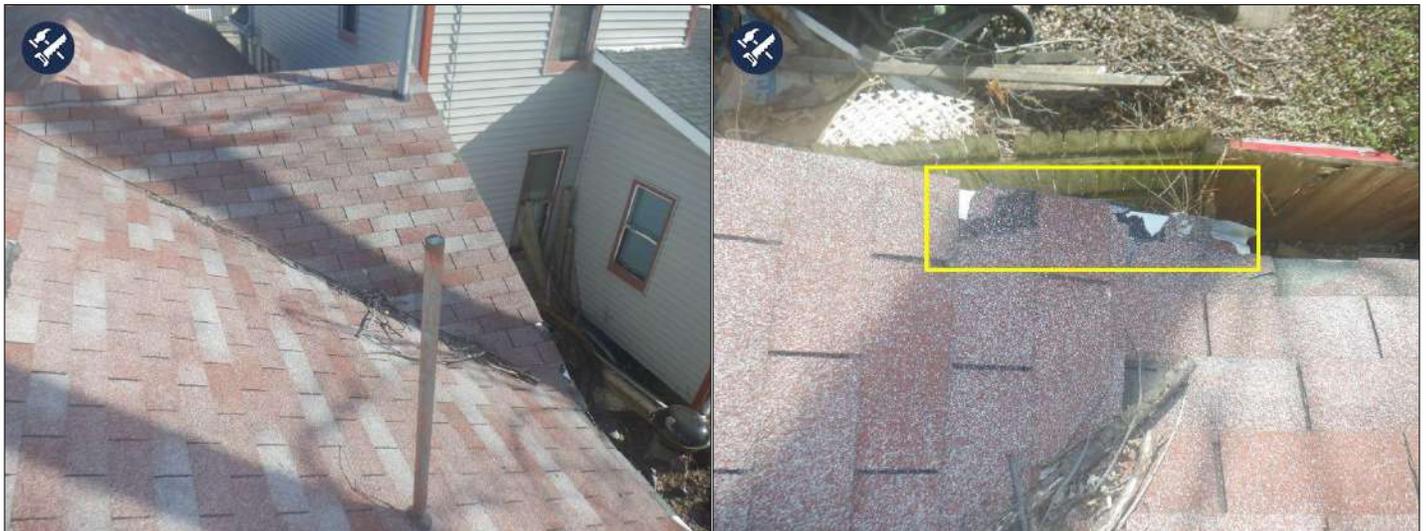
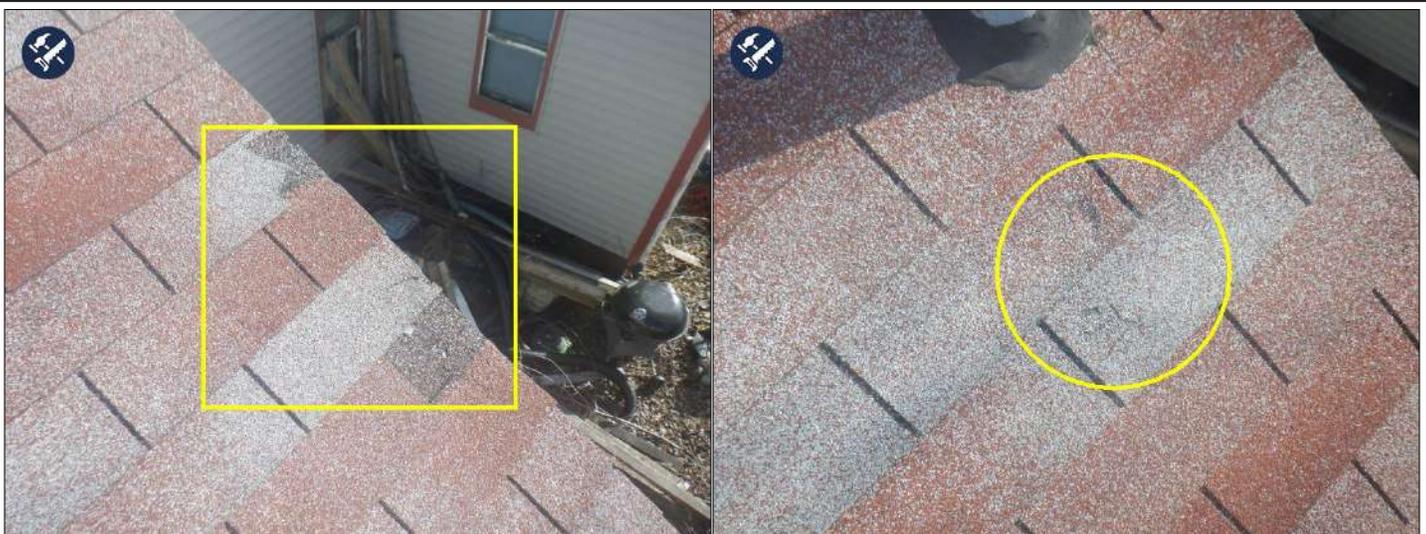
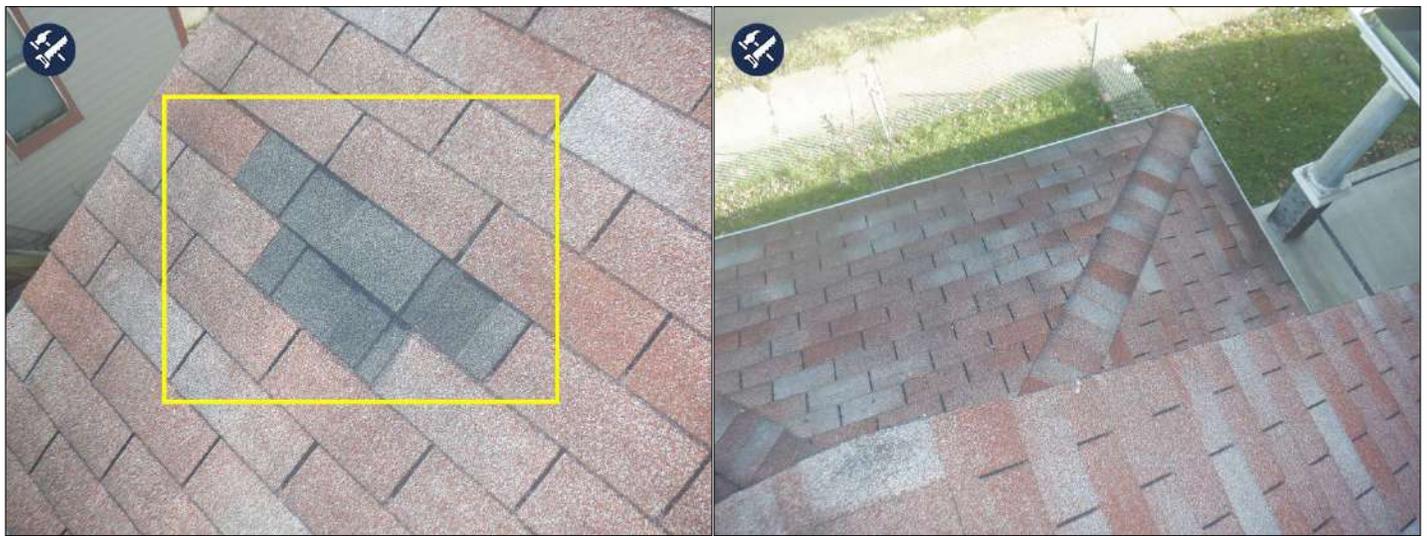
Possible Concern: The roof appeared to be nearing end of its useful life. There were multiple layers of roof material installed on the decking with the top layer displaying signs of curling, cracking, granule loss, missing and damaged shingles and previous repairs – recommend having a roofing specialist inspect and evaluate for continued use.

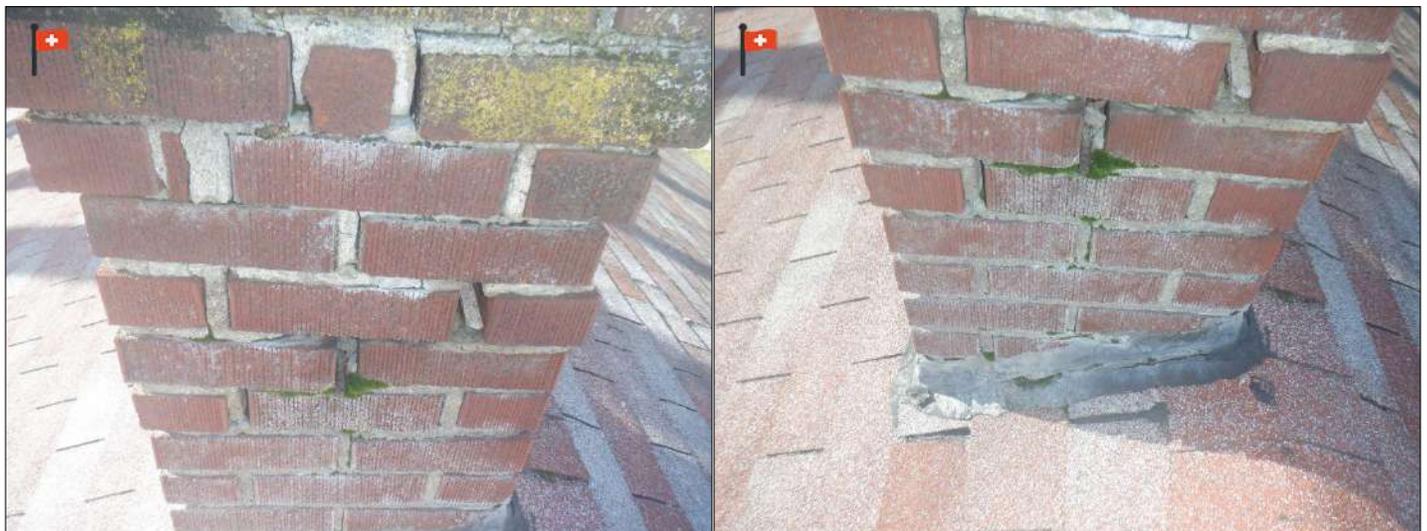
Page 34 Item: 1 Chimney Conditions

Repair: The chimney had loose bricks or stones, which could create a safety hazard - recommend having a chimney specialist inspect and evaluate for possible repairs.

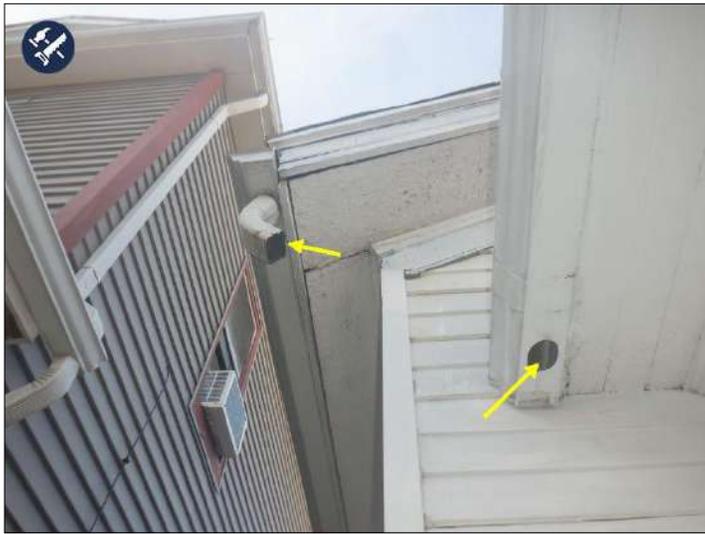
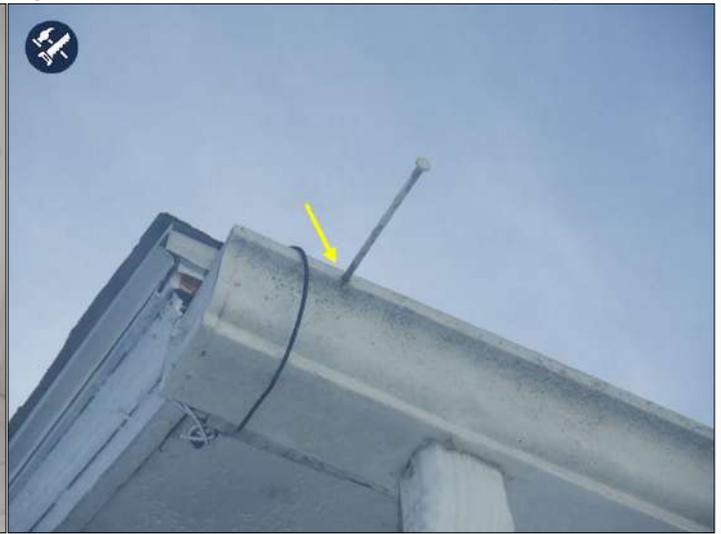
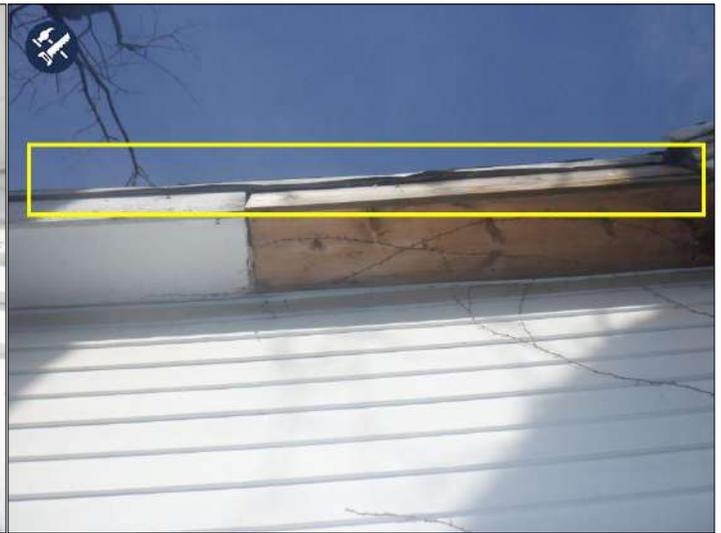
Page 34 Item: 2

Repair: The gutters and/or downspouts were missing sections on the entire exterior of the home. This condition can result in excessively high moisture levels in soil at the foundation and can cause damage related to soil/foundation movement. Excessive moisture levels in soil near the foundation can effect the ability of the soil to support the weight of the structure above and can cause damage related to soil/foundation movement - recommend repair.

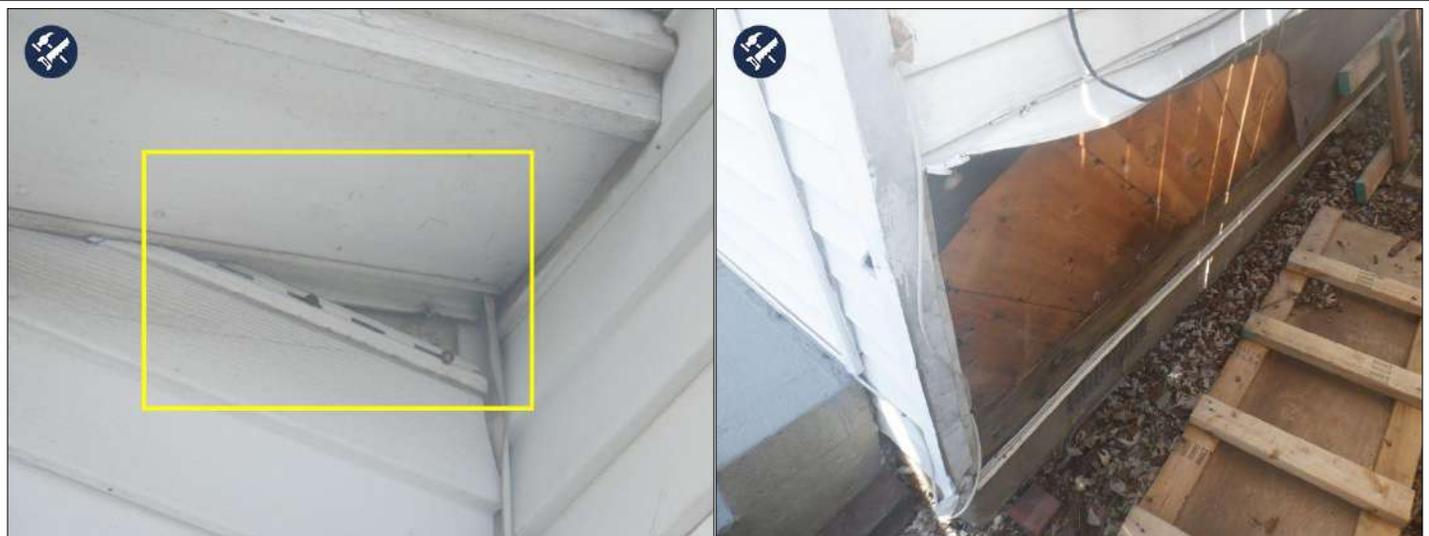
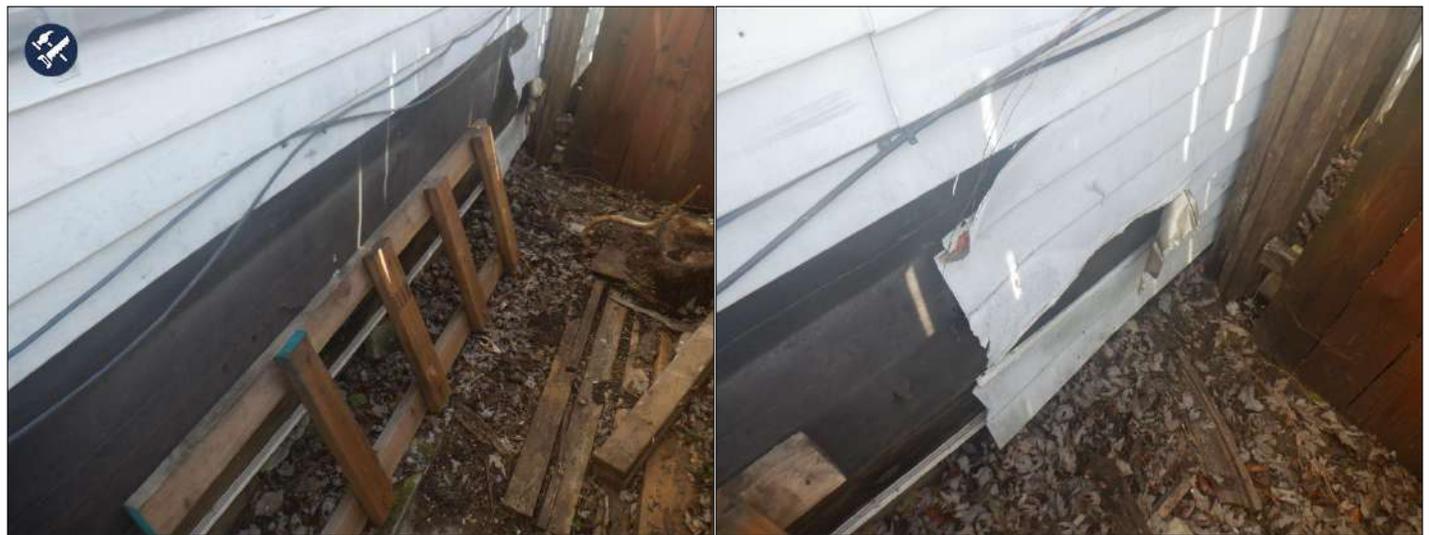
Page 35 Item: 3

• Repair: The rear exterior dryer duct vent is missing the cover - recommend repair.
 • Major Concern, Repair: Substantial damages and improper installation was observed on the entirety of the exterior siding, repair or replacement may be needed - recommend having a siding specialist inspect and evaluate for possible repairs.

Major Concern, Repair: Substantial damages and improper installation was observed on the entirety of the exterior siding, repair or replacement may be needed - recommend having a siding specialist inspect and evaluate for possible repairs.

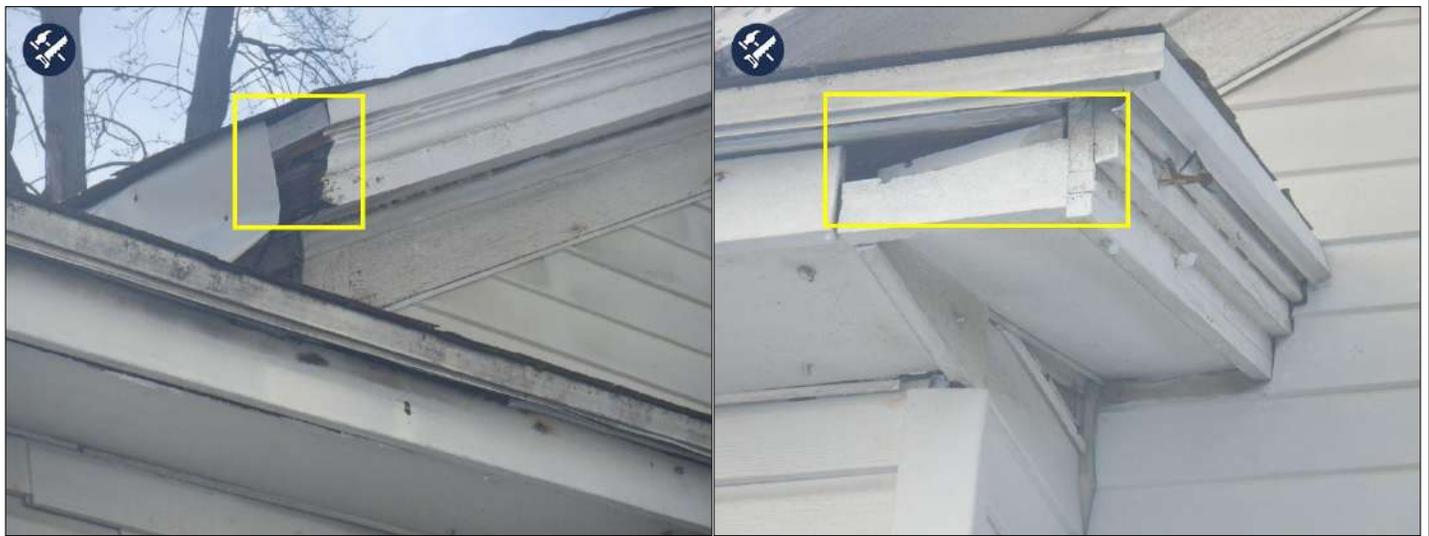
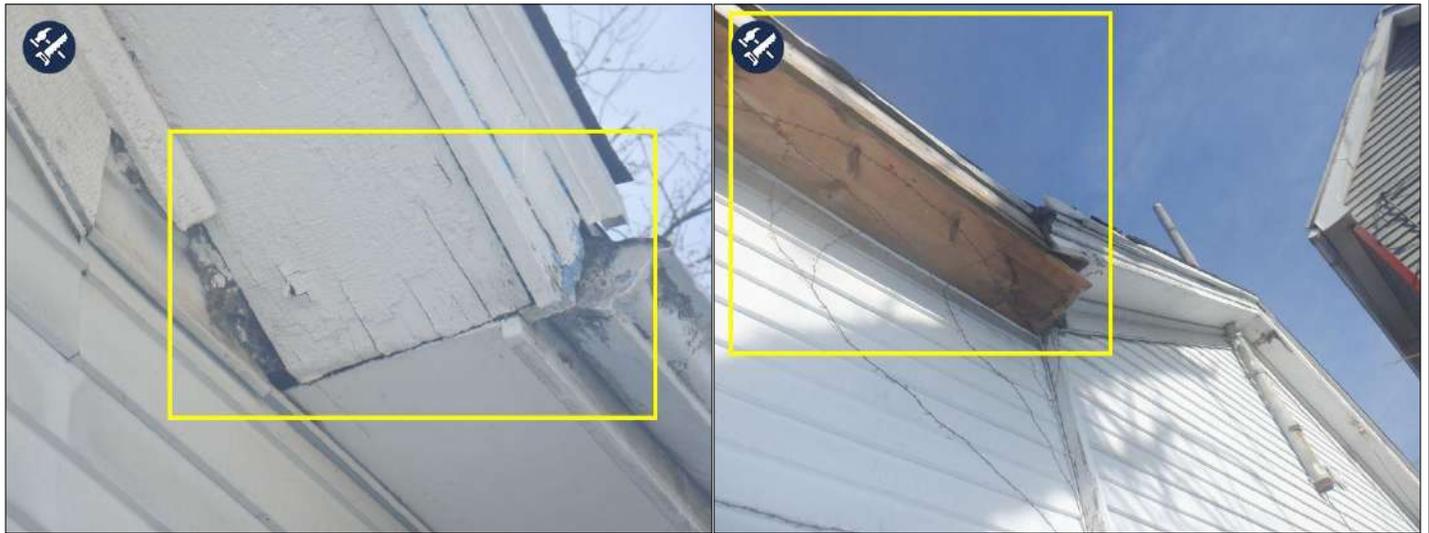
Page 36 Item: 5

Repair: The fascia and/or soffit was damaged and deteriorated in multiple locations - recommend further inspection and evaluation by a qualified contractor with repairs as needed.

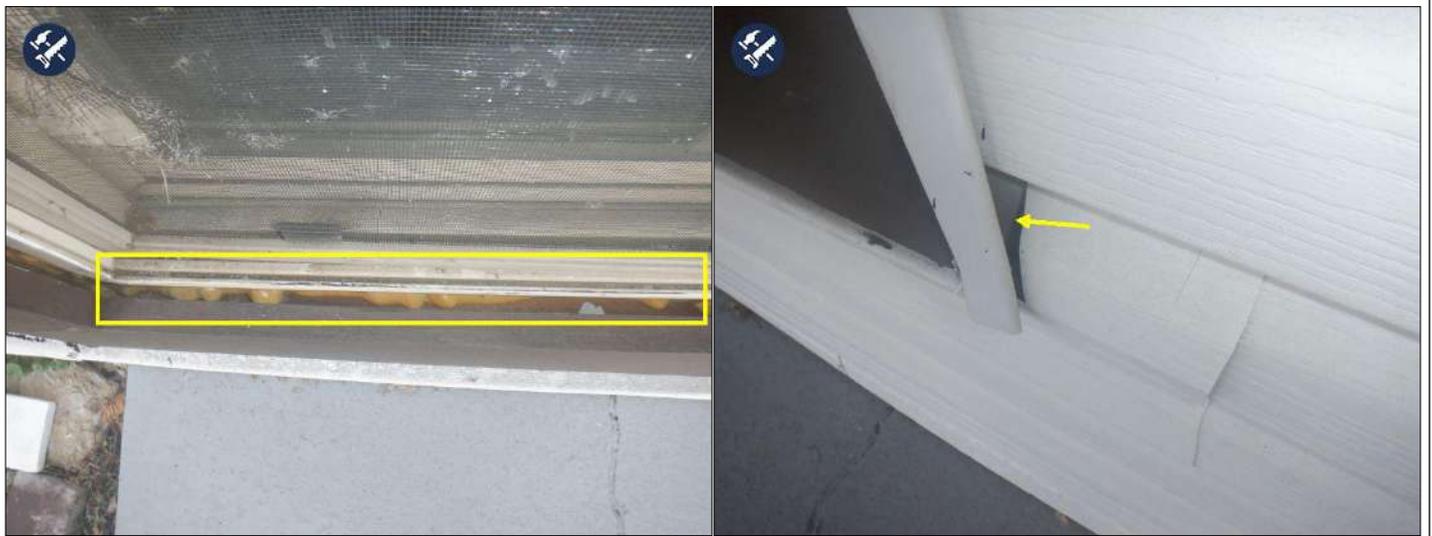
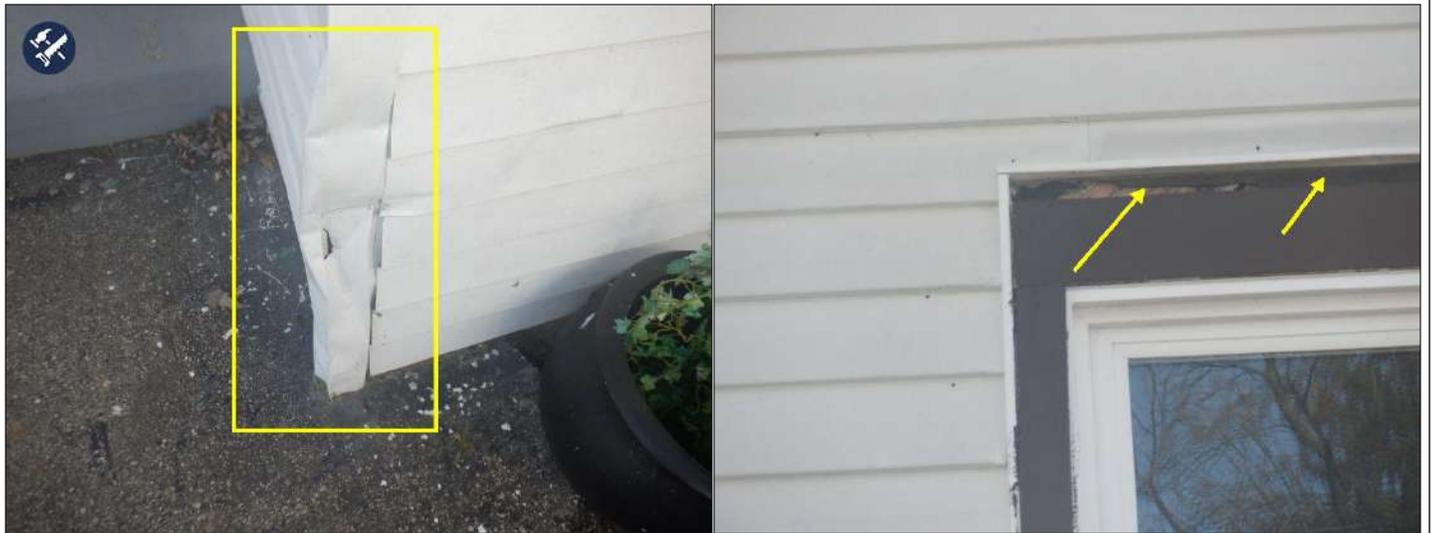
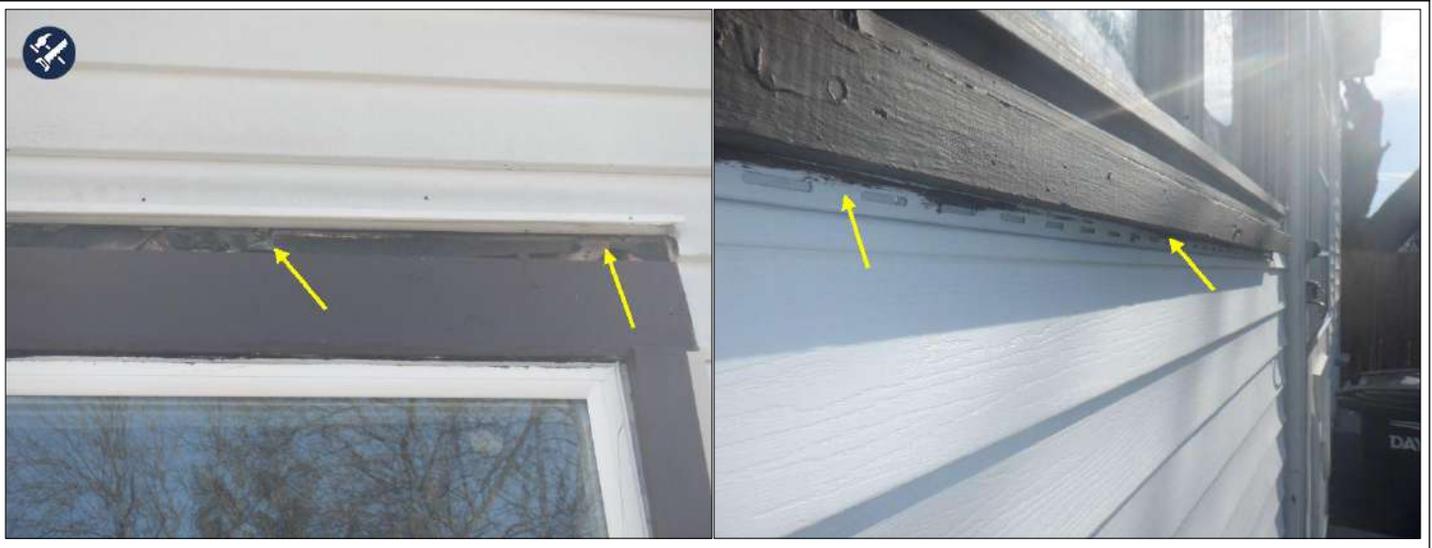
Page 37 Item: 6

Repair: The trim was missing, gapped or damaged around the window and at the exterior corners of the home in multiple locations – recommend further inspection and evaluation by a qualified contractor with repairs as needed.

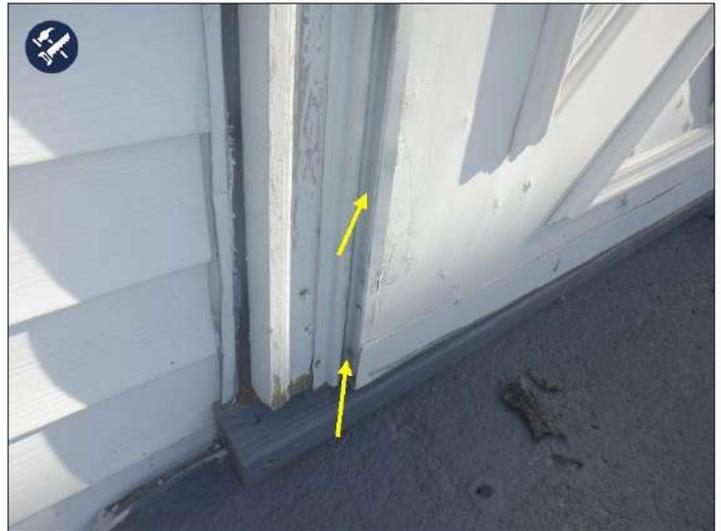
Repair: The rear storm door is damaged and in need of repair/replacement - recommend repair.

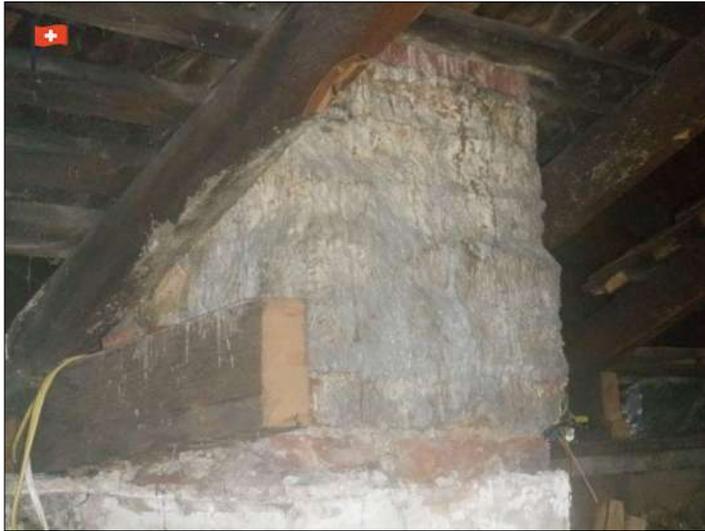
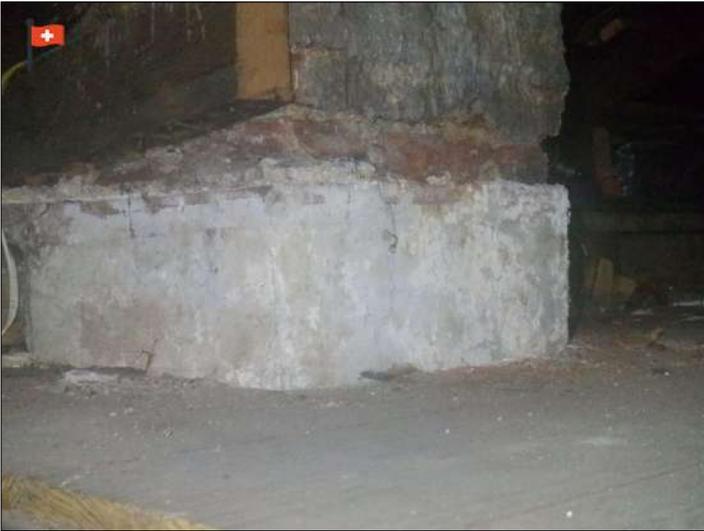
Page 40 Item: 6 **Attic Chimney Conditions** • Repair, SAFETY ISSUE: In the attic, the chimney section showed deterioration - recommend having a chimney specialist inspect and evaluate for possible repairs.

Repair, SAFETY ISSUE: In the attic, the chimney section showed deterioration - recommend having a chimney specialist inspect and evaluate for possible repairs.

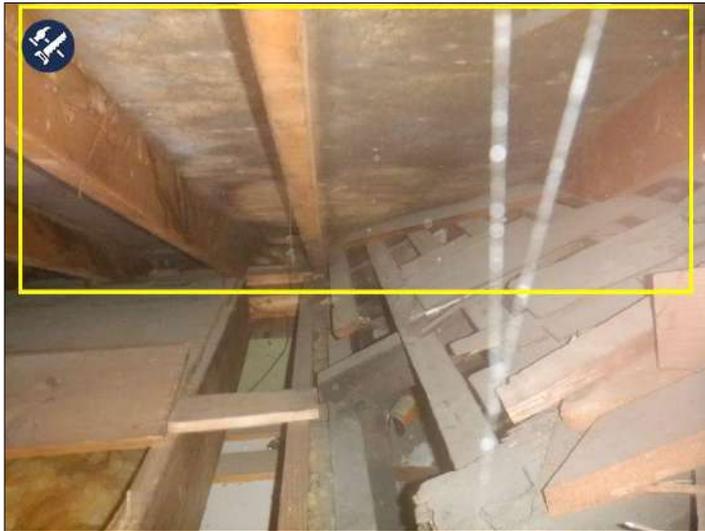
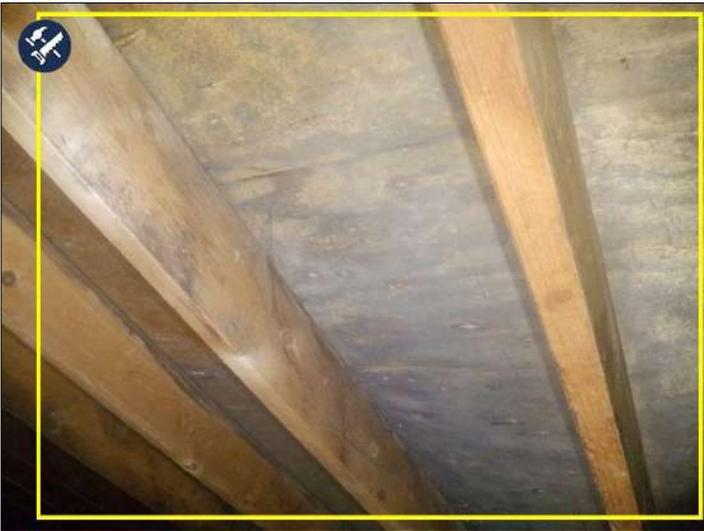
Page 41 Item: 9 **Attic Mold/Moisture Conditions** • Possible Concern: Throughout the rear of the attic, biogrowth was found on the roof sheathing and framing - recommend having a mold remediator inspect and evaluate the entire attic for possible repairs.

Possible Concern: Throughout the rear of the attic, biogrowth was found on the roof sheathing and framing - recommend having a mold remediator inspect and evaluate the entire attic for possible repairs.

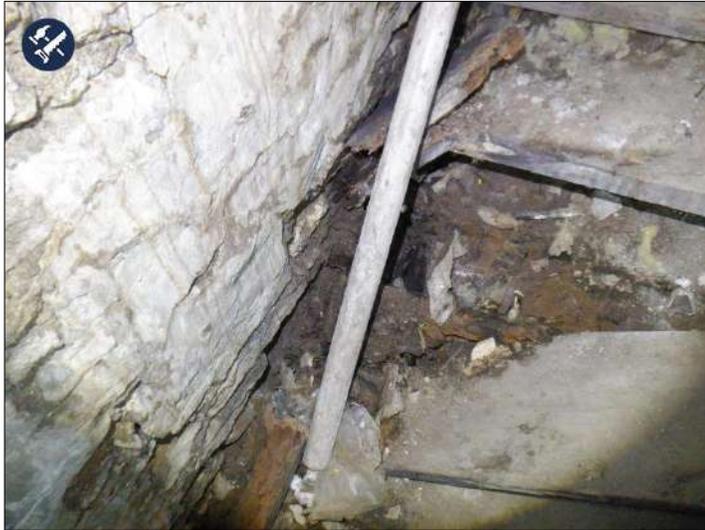
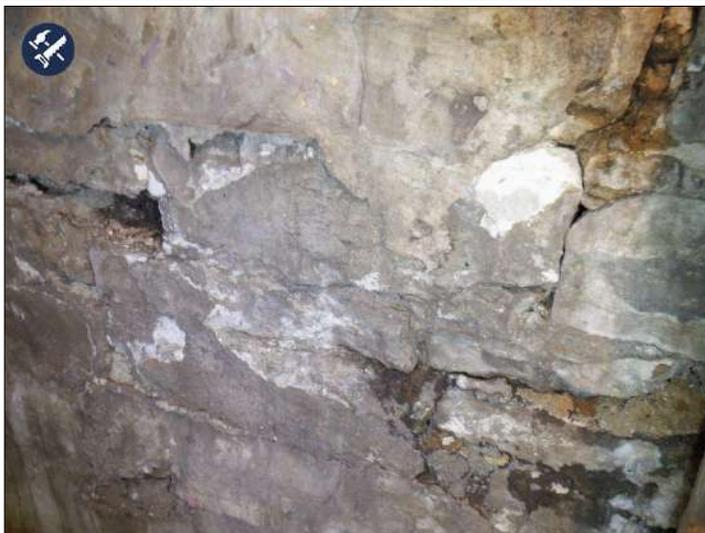
Basement Foundation Conditions

Major Concern, Repair: The basement foundation walls have cracks, visible daylight, bowing and heaving and structural movement of the building appears to have occurred. Repairs are needed to protect the house from more serious damage. The rate of movement cannot be predicted during a one-time inspection. In addition, there was evidence of a significant ongoing moisture intrusion issue noted via water damaged wood, staining and streaking on the walls and the dirt floors. A structural engineer or a company specializing in foundation repairs should be consulted to evaluate the condition and suggest corrective measures.

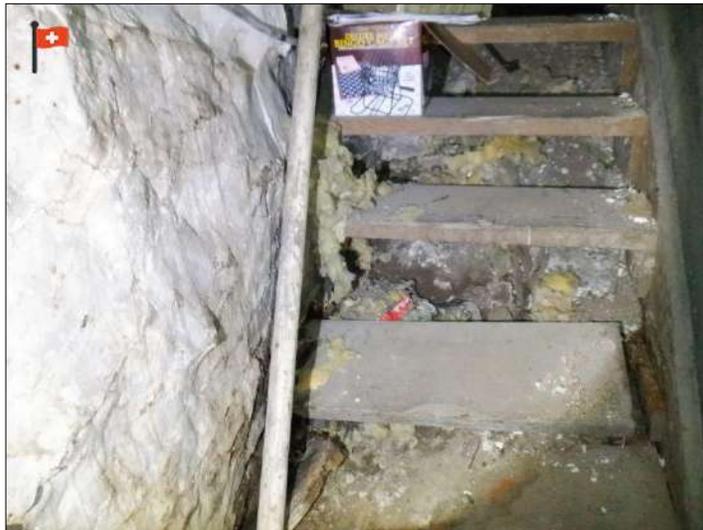
Page 44 Item: 6

Repair, SAFETY ISSUE: In the basement, the stairs are in very bad condition and in need of immediate repair/replacement - recommend repair for safety.

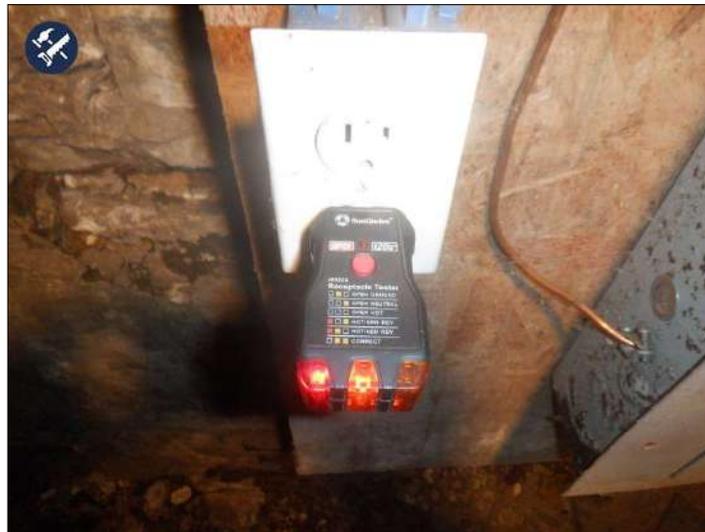
Page 45 Item: 7

Repair: The basement electrical outlet next to the electrical panel is wired with hot neutral reverse polarity - recommend having an electrical specialist inspect and evaluate for repairs.

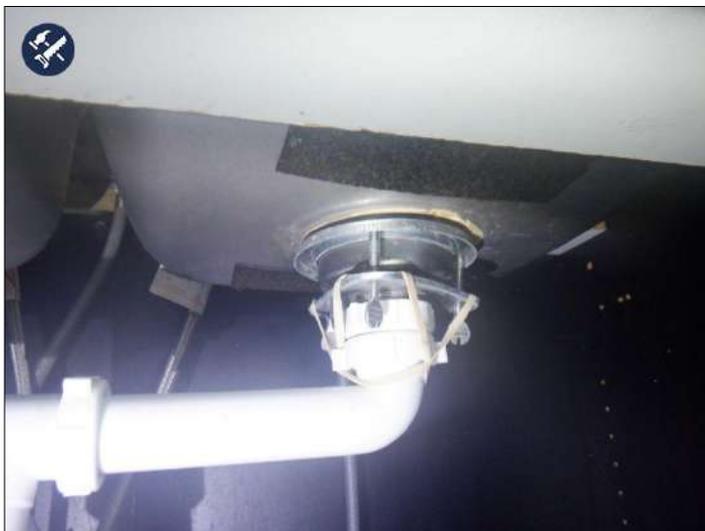
Repair: The kitchen sink drain line leaks when in use – recommend having a plumbing specialist inspect and evaluate for possible repairs.

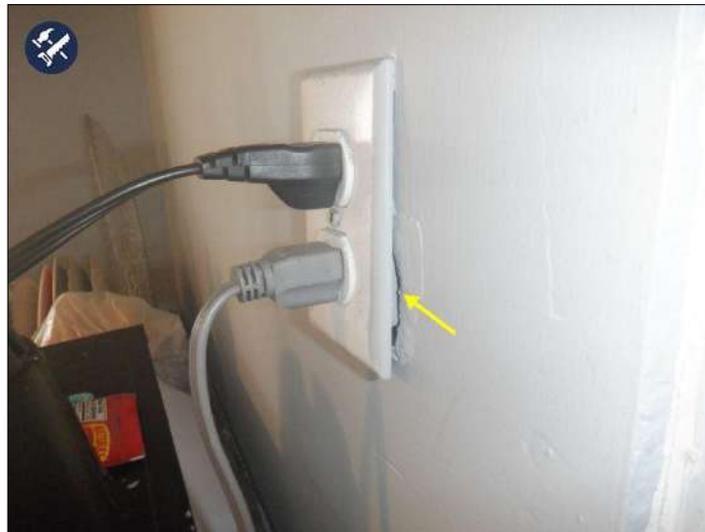
Repair: The kitchen electrical outlet on the wall by the rear bedroom door electrical outlet is damaged - recommend having an electrical specialist inspect and evaluate for repairs.

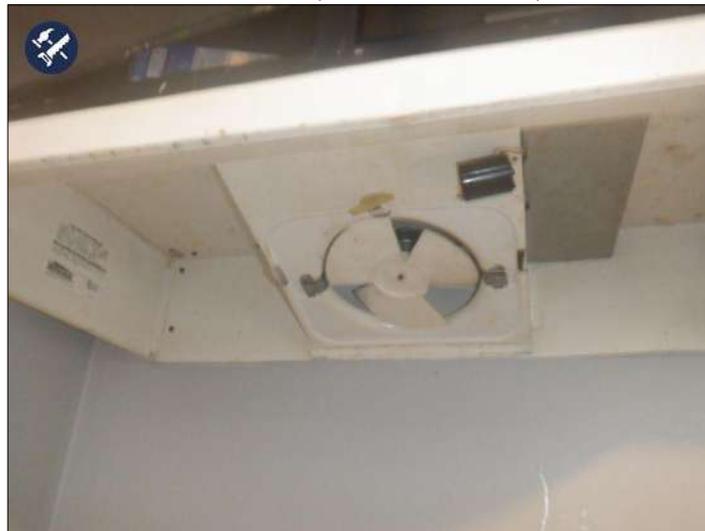
Page 46 Item: 4

Repair: The kitchen exhaust fan does not respond to the control switch and should be serviced or replaced - recommend repair.

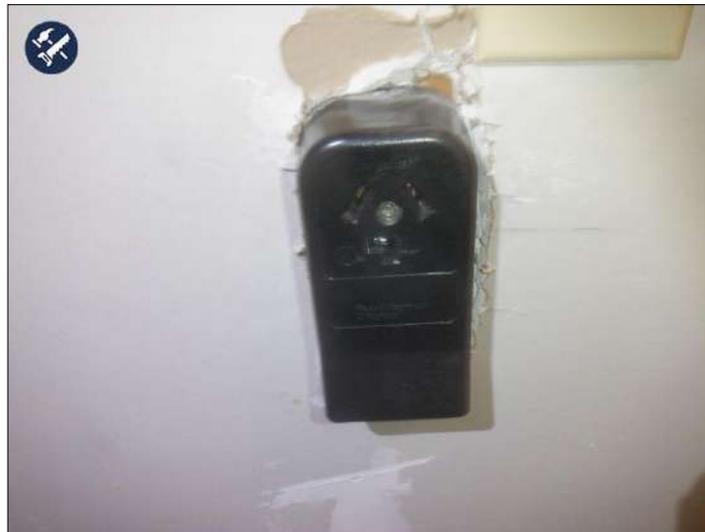
Laund/Util -
Electrical
Conditions

Repair: The wiring leading to the clothes dryer is a 3 prong type receptacle. Newer units have 4 prong receptacles. This may need to be upgraded to a newer type when changing dryers. Many homes may have circumstances where construction practices or standards have changed since the home was built. Updating/upgrading systems are not a requirement if the home was built to the standards of the day construction was completed. It would be cost prohibitive to bring everything to current standards for every home.

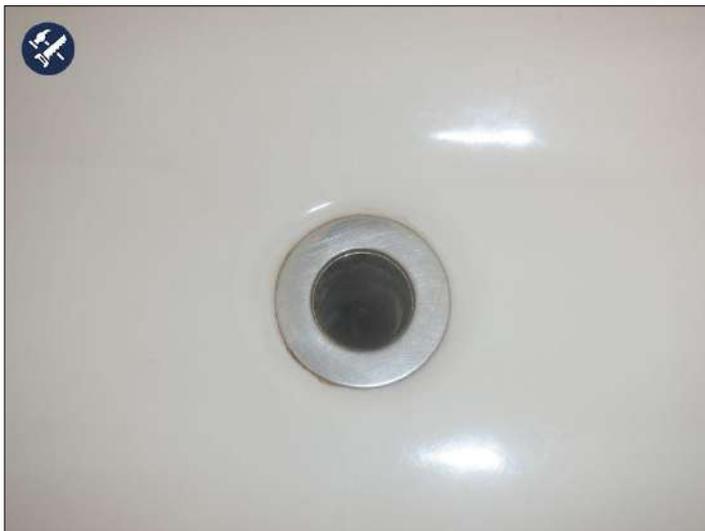
Repair: The sink drain stopper is missing hardware – recommend having a plumbing specialist inspect and evaluate for possible repairs.

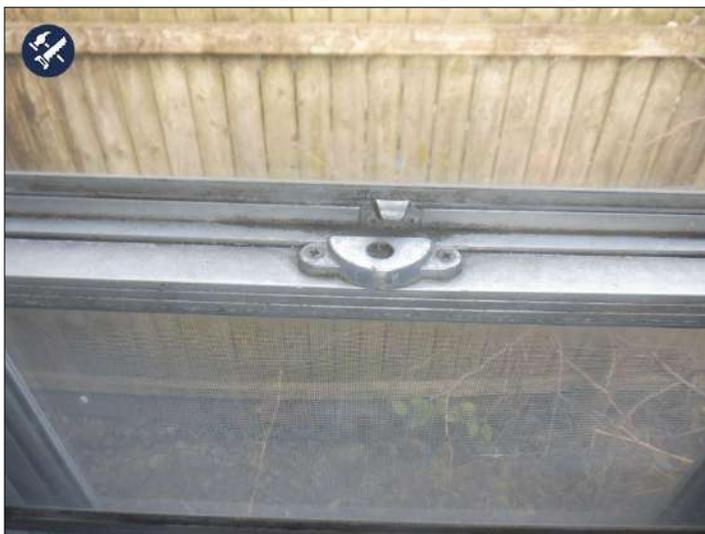
Bathroom - Interior Conditions

Repair: The window above the toilet has damaged hardware (locks, cranks, or handles), and a broken counter balance - recommend having a window specialist inspect and evaluate for repairs/replacement.

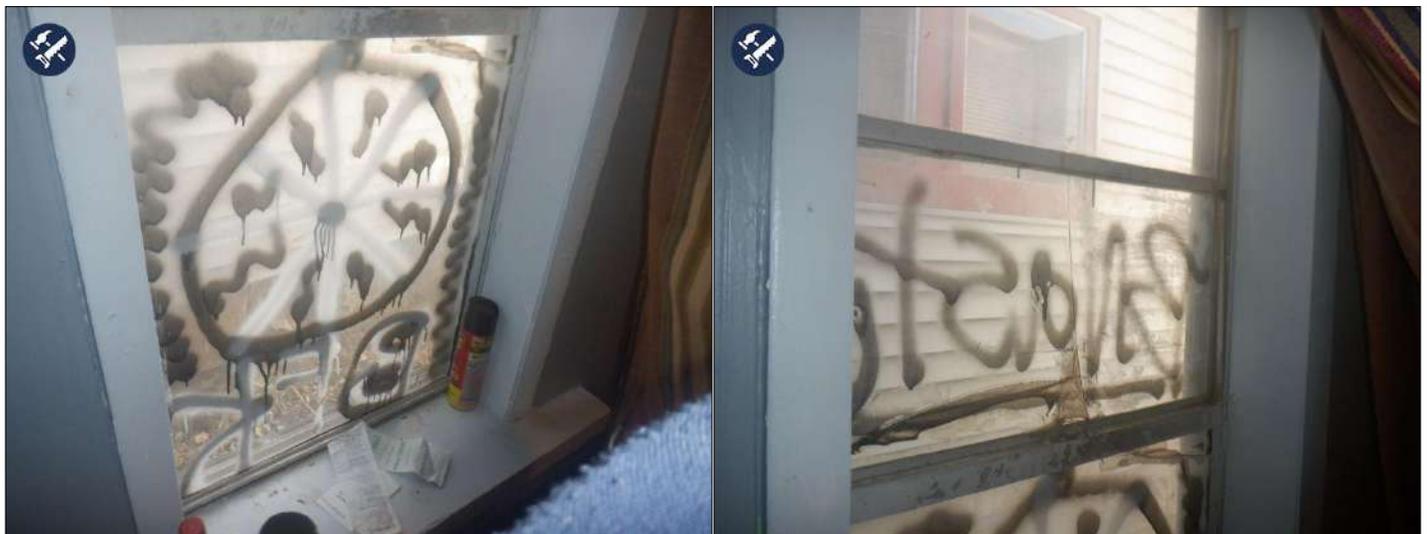
Repair: The window has cracked glass and has been spray painted - recommend having a window specialist inspect and evaluate for repairs/replacement.

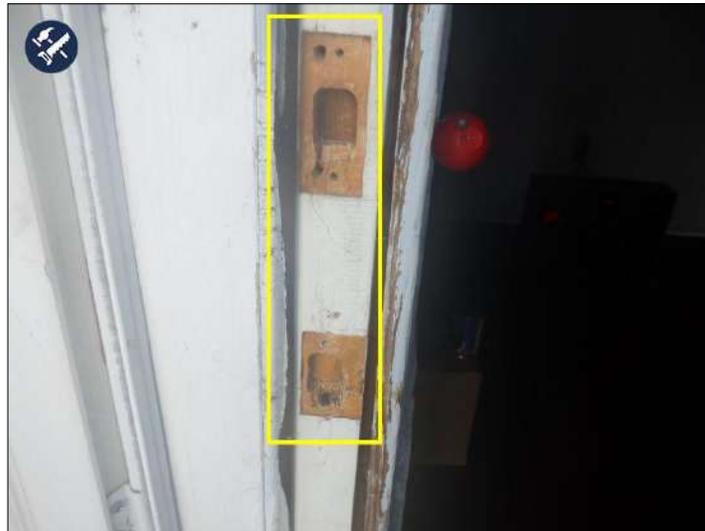
Repair: The front entry door is missing the striker plates for the door handle and deadbolt – recommend repair.

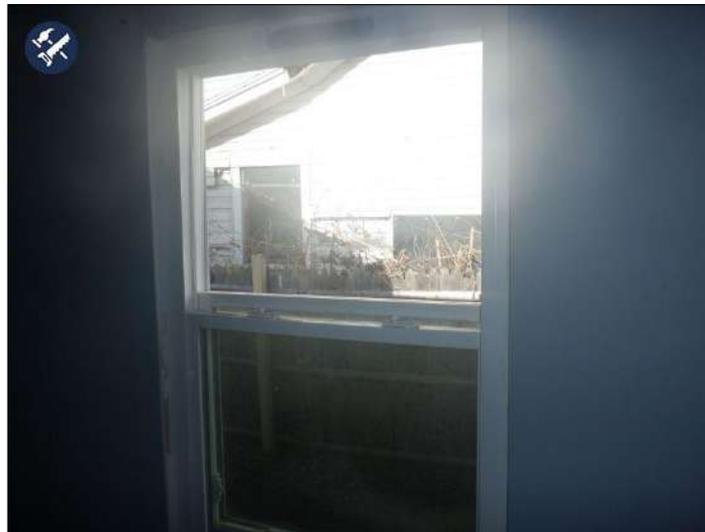
Repair: The upper pane of the side wall window has a broken counterbalance - recommend having a window specialist inspect and evaluate for repairs/replacement.

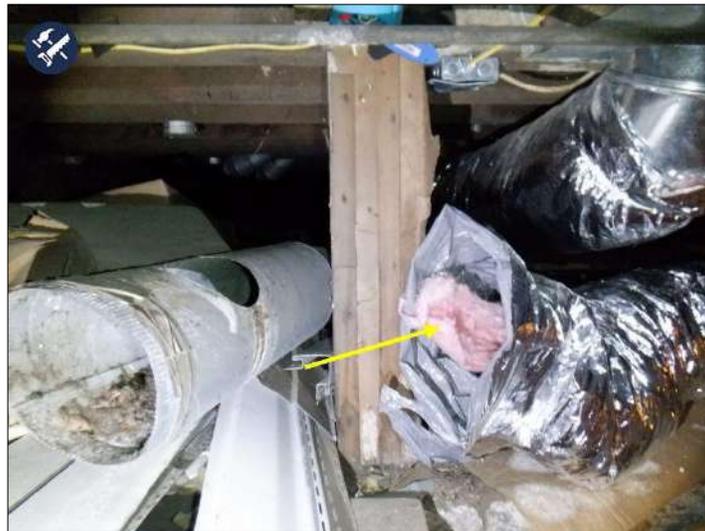
Repair: The HVAC ductwork in the basement is not connected - recommend having a licensed HVAC specialist inspect and evaluate for repairs.

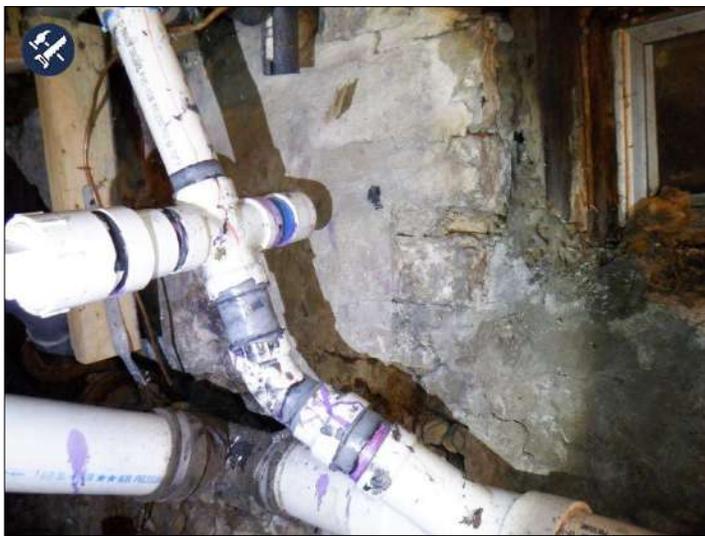
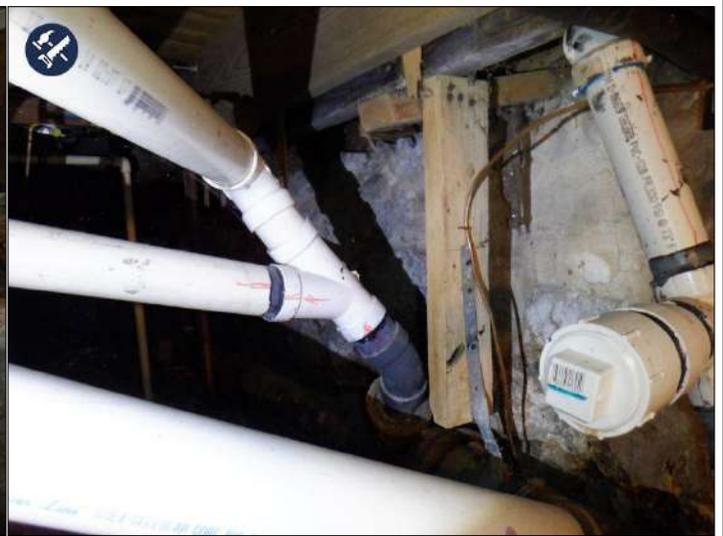
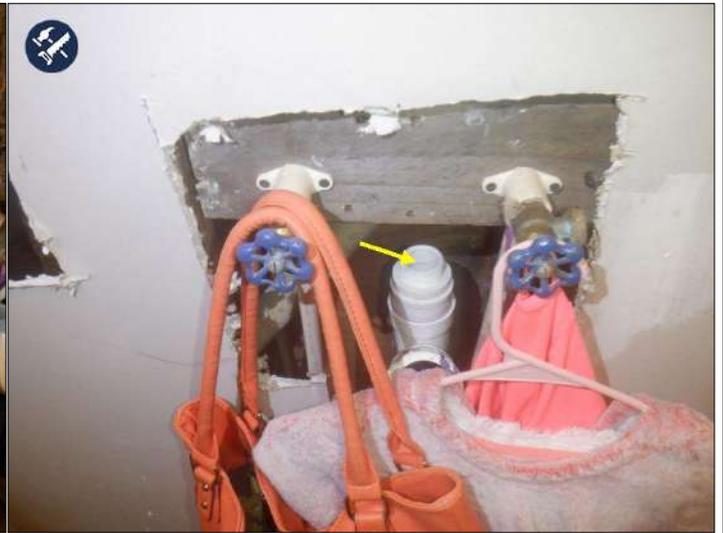
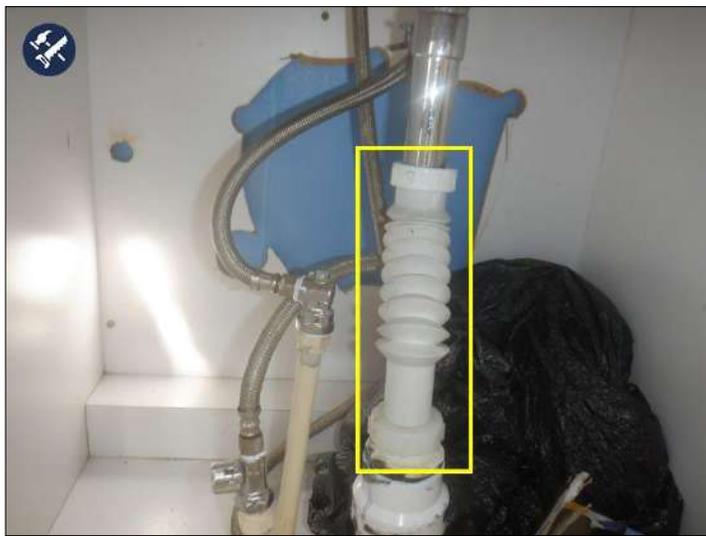
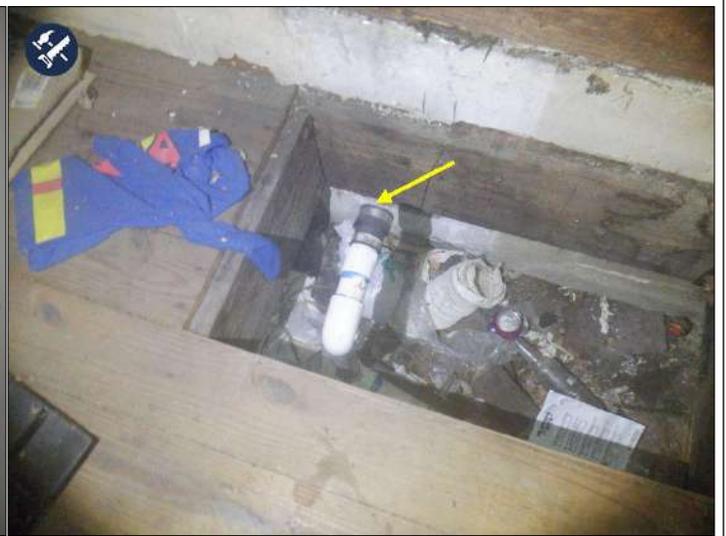
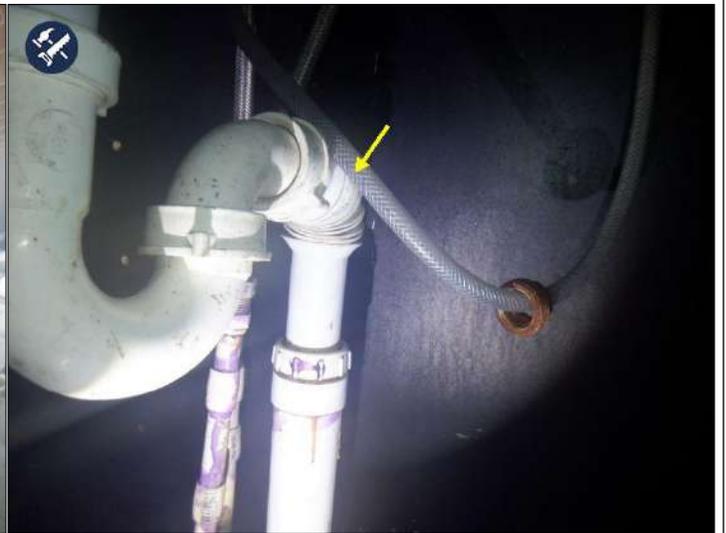
Possible, Concern, Repair: The plumbing fixtures, drain lines and vents were observed as improperly and unprofessionally installed throughout the home. Improper connections were noted in the basement, missing vent covers and caps were observed in the laundry room, improper drains/traps were observed under the sinks and the plumbing ventilation in the attic was not connected near the access panel and was not professionally installed in the rear of the attic. The inspection HIGHLY recommends the incoming, outgoing and plumbing vents lines all be inspected and evaluated further by a plumbing specialist for possible repairs.
