PROPERTY INSPECTION REPORT

Tony Burk
OHI.2019004151 expr. 8/1/2022
Accutech Home Inspections

123 Main St
Inspection Prepared For: Owner Homer
Agent:

Date of Inspection: 3/12/21
Age of House: 1895 Size: 1148
Weather: Overcast

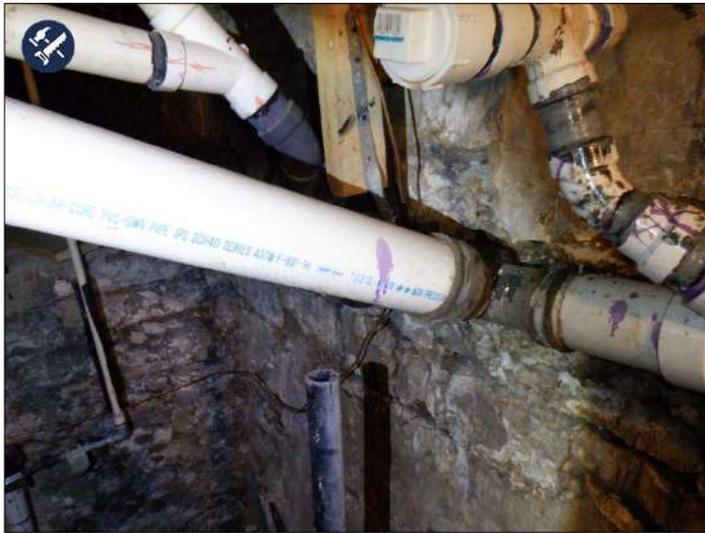
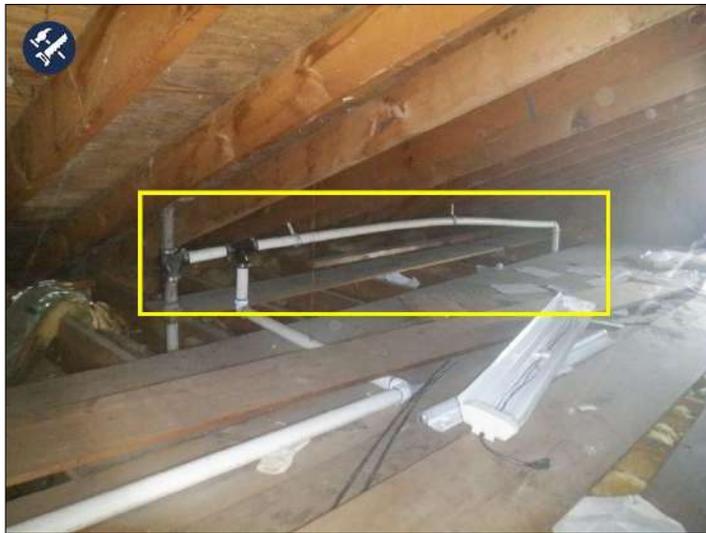
Possible, Concern, Repair: The plumbing fixtures, drain lines and vents were observed as improperly and unprofessionally installed throughout the home. Improper connections were noted in the basement, missing vent covers and caps were observed in the laundry room, improper drains/traps were observed under the sinks and the plumbing ventilation in the attic was not connected near the access panel and was not professionally installed in the rear of the attic. The inspection HIGHLY recommends the incoming, outgoing and plumbing vents lines all be inspected and evaluated further by a plumbing specialist for possible repairs.

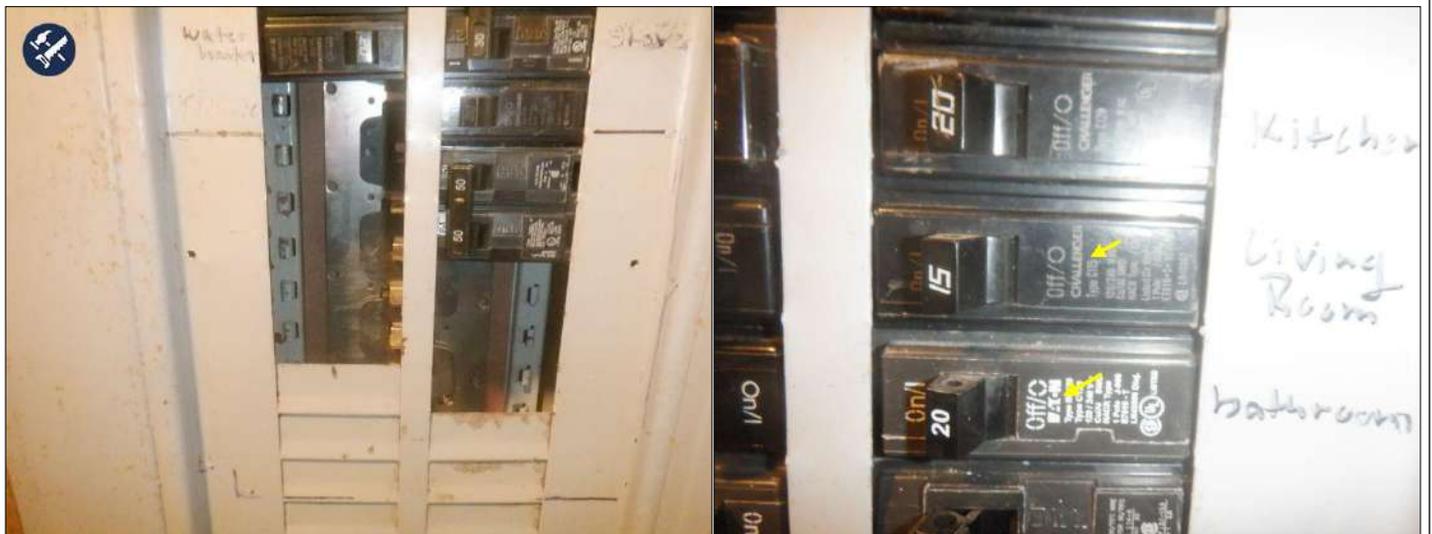
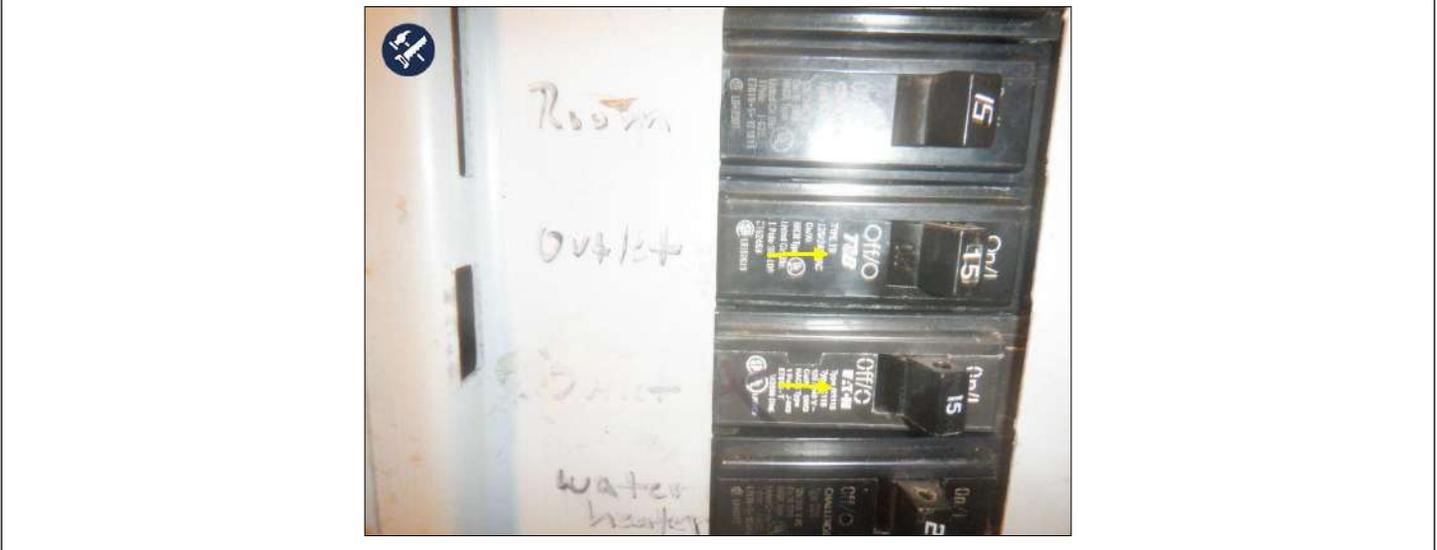
Repair: The electrical panel has open 'knockouts'. In addition, there were breakers from multiple manufactures noted in the panel. It is HIGHLY suggested that the breakers in the panels all are from the same manufacturer - recommend having a licensed electrical specialist inspect and evaluate for repairs.

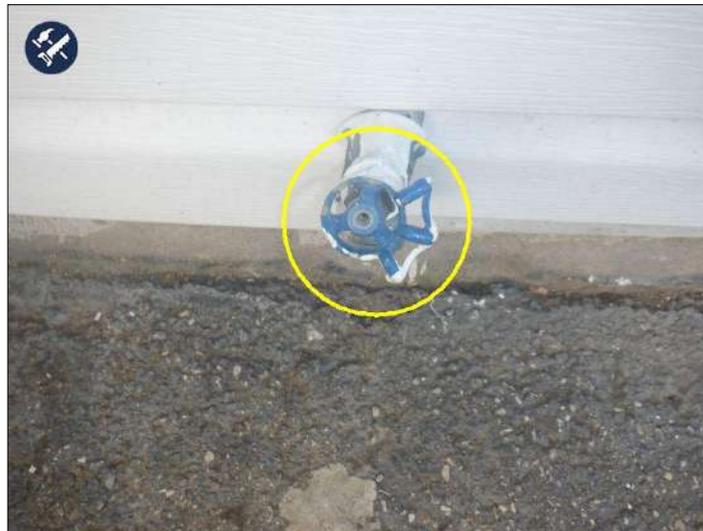
Repair: The left exterior water spigot handle was broken – recommend repair.

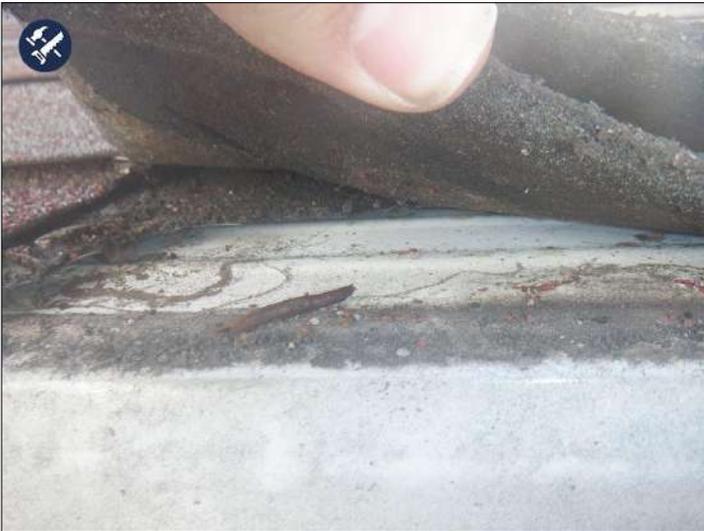
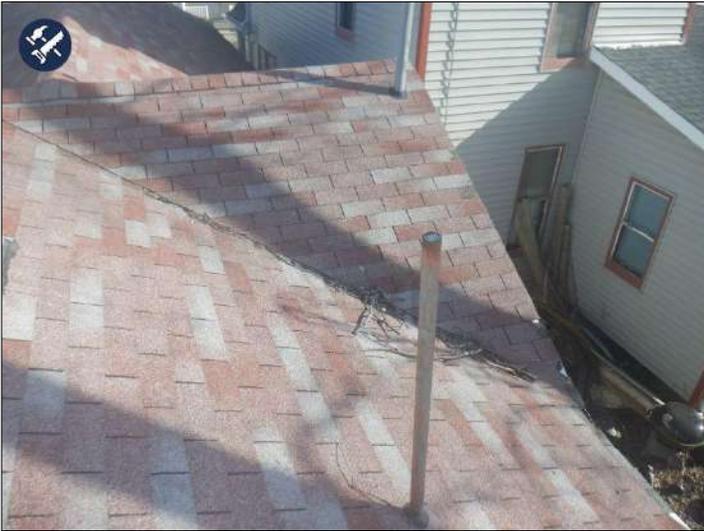
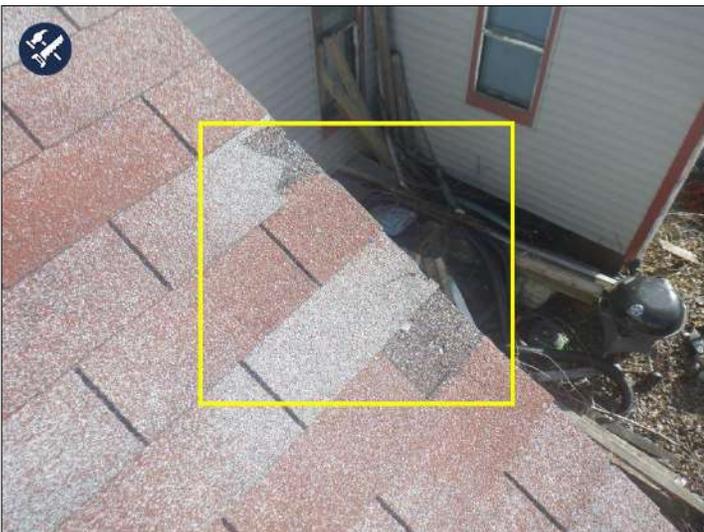
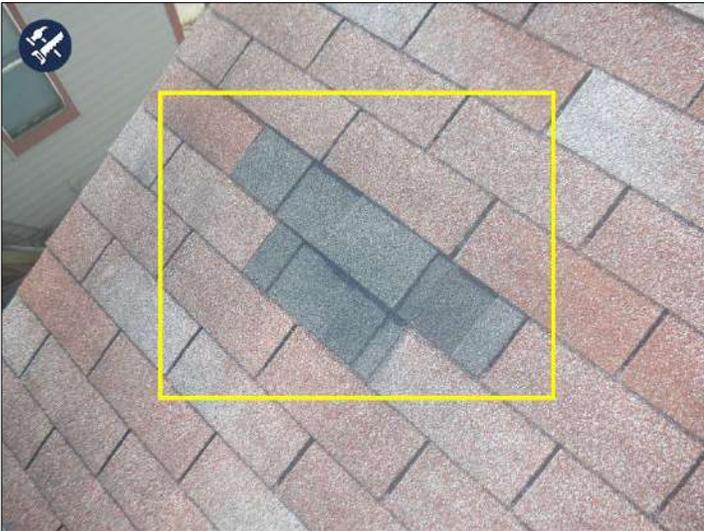
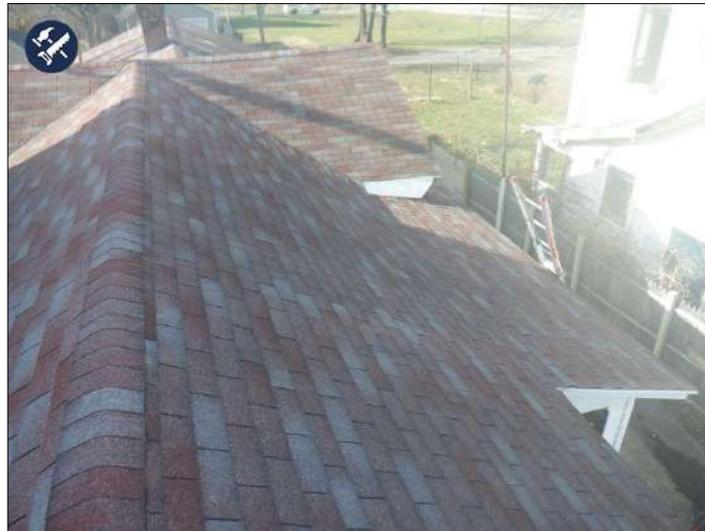
• Monitor: Multiple layers of roofing material have been installed on the roof decking. This practice has been permitted by state & local building codes. However, additional layers of roofing material add great amounts of weight to the roof support structure. Multiple layers of roofing immediately void the warranties of most roofing manufacturers. The practical life time of the newer layer of roofing will be reduced as much as 25%-33% of the estimated lifetime. The client is strongly advised to consider removing all of the existing layers of roofing the next time the home is re-roofed.

Possible Concern: The roof appeared to be nearing end of its useful life. There were multiple layers of roof material installed on the decking with the top layer displaying signs of curling, cracking, granule loss, missing and damaged shingles and previous repairs – recommend having a roofing specialist inspect and evaluate for continued use.

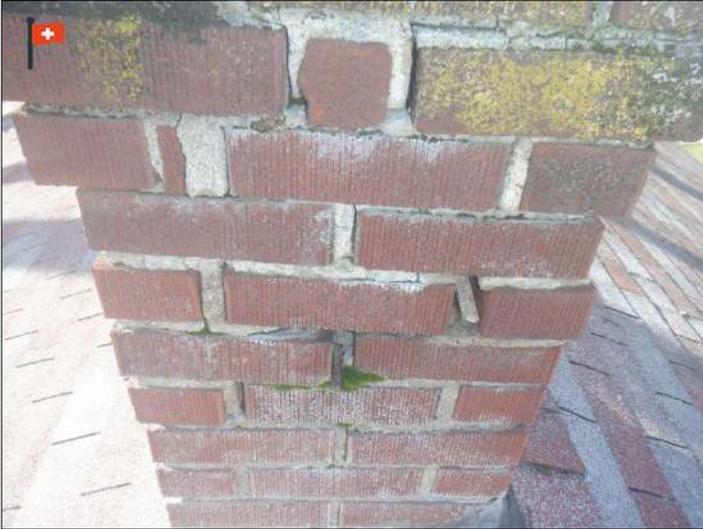
Repair: The chimney had loose bricks or stones, which could create a safety hazard - recommend having a chimney specialist inspect and evaluate for possible repairs.

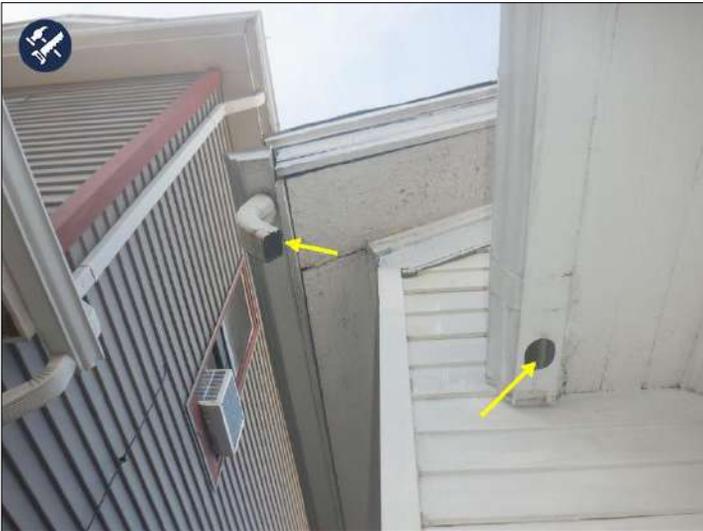
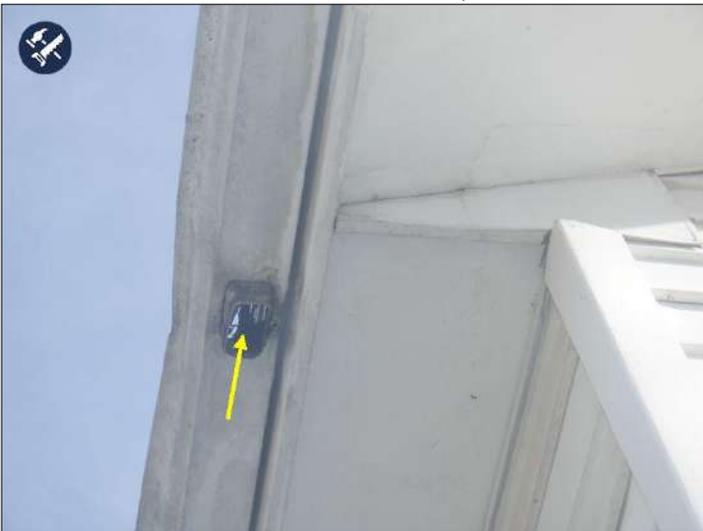
2. Gutters Conditions

Repair: The gutters and/or downspouts were missing sections on the entire exterior of the home. This condition can result in excessively high moisture levels in soil at the foundation and can cause damage related to soil/foundation movement. Excessive moisture levels in soil near the foundation can effect the ability of the soil to support the weight of the structure above and can cause damage related to soil/foundation movement - recommend repair.

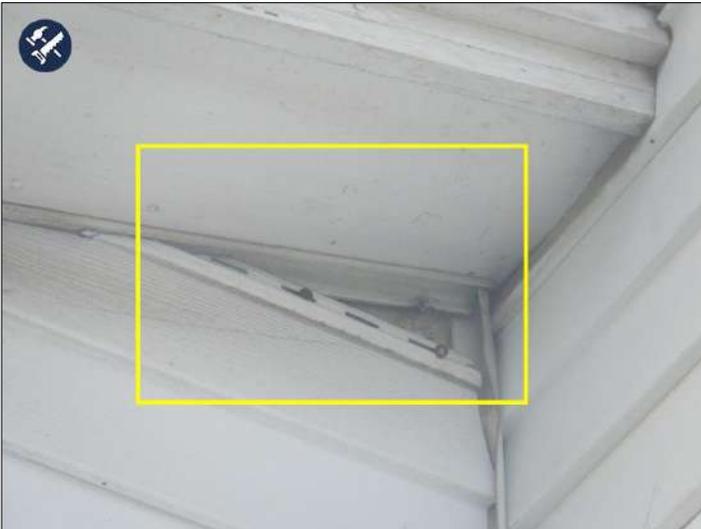
3. Siding Conditions

Major Concern, Repair: Substantial damages and improper installation was observed on the entirety of the exterior siding, repair or replacement may be needed - recommend having a siding specialist inspect and evaluate for possible repairs.

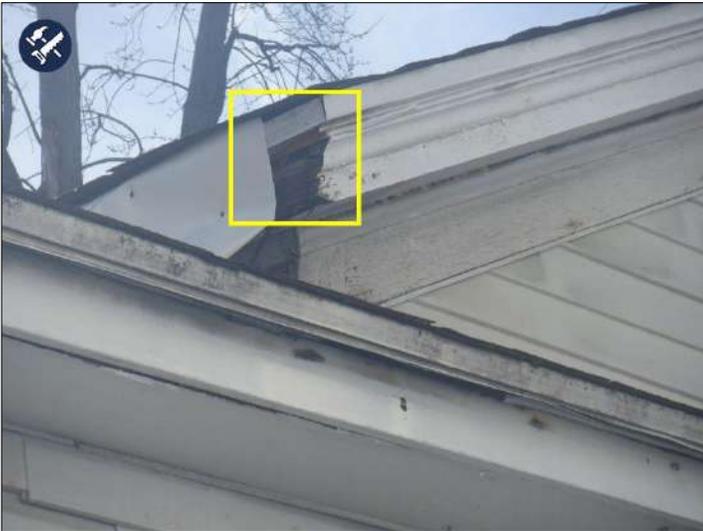
• Repair: The fascia and/or soffit was damaged and deteriorated in multiple locations - recommend further inspection and evaluation by a qualified contractor with repairs as needed.

Repair: The fascia and/or soffit was damaged and deteriorated in multiple locations - recommend further inspection and evaluation by a qualified contractor with repairs as needed.

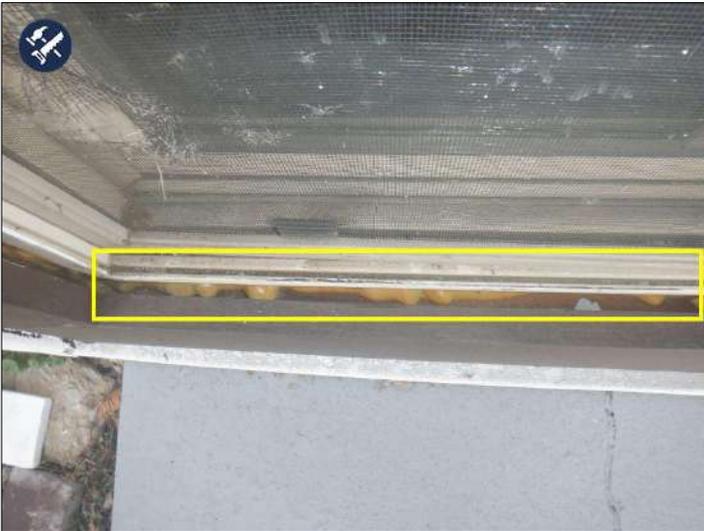
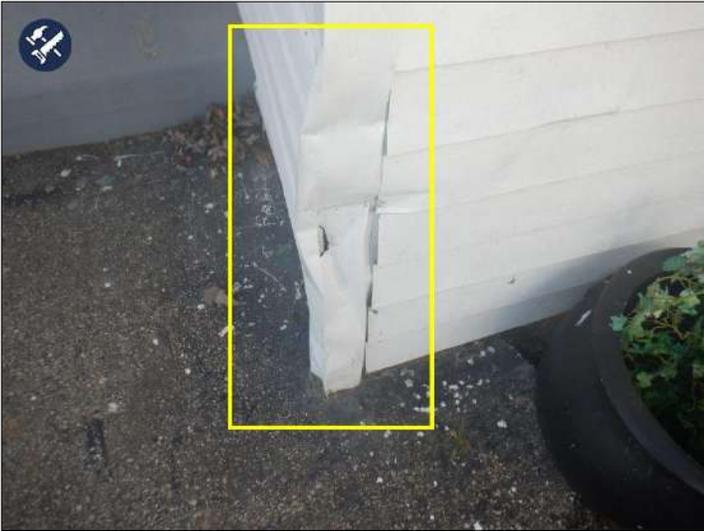
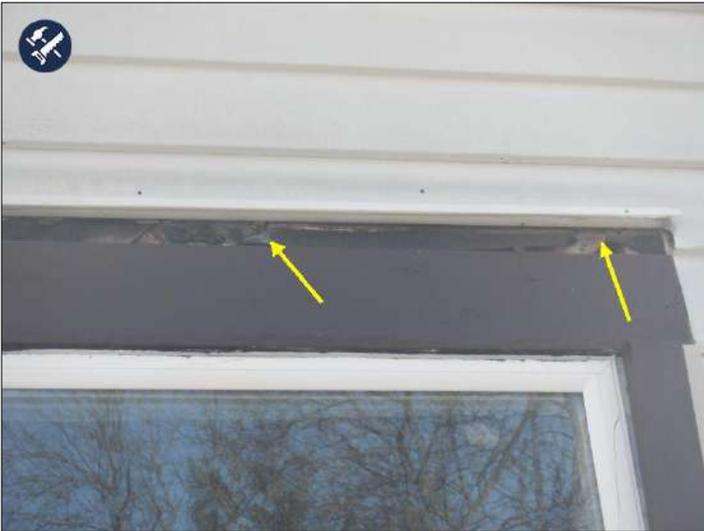
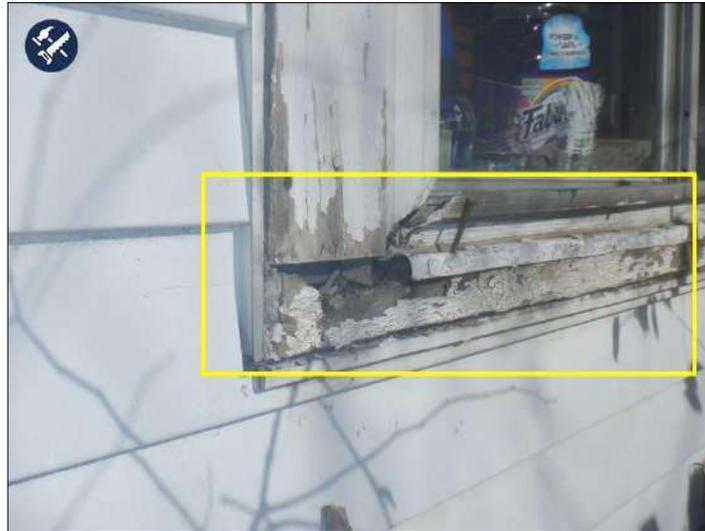
• Repair: The trim was missing, gapped or damaged around the window and at the exterior corners of the home in multiple locations – recommend further inspection and evaluation by a qualified contractor with repairs as needed.

Repair: The trim was missing, gapped or damaged around the window and at the exterior corners of the home in multiple locations – recommend further inspection and evaluation by a qualified contractor with repairs as needed.

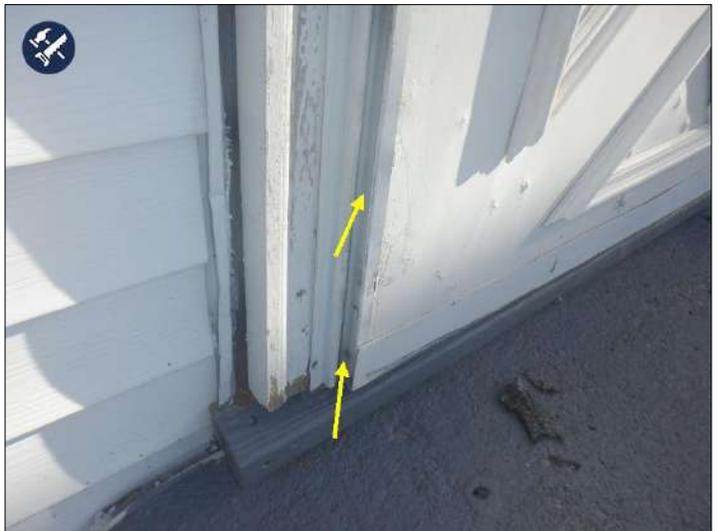
Repair: The front storm door is not connected to a hinge and does not close - recommend repair/replacement. Repair: The rear storm door is damaged and in need of repair/replacement - recommend repair.

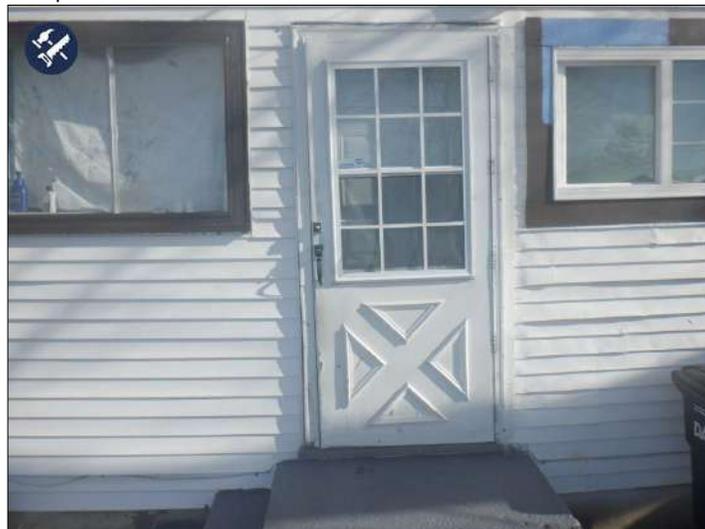
- Repair: The rear storm door is damaged and in need of repair/replacement - recommend repair.
- Repair: The front storm door is not connected to a hinge and does not close - recommend repair/replacement.

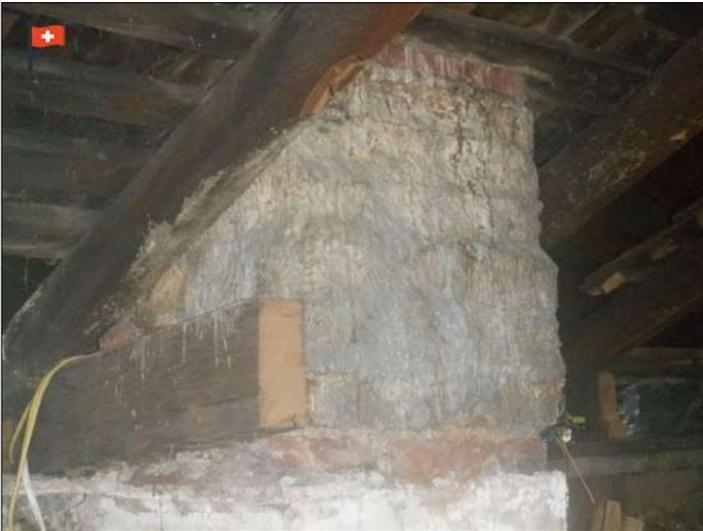
- Repair, SAFETY ISSUE: In the attic, the chimney section showed deterioration - recommend having a chimney specialist inspect and evaluate for possible repairs.

Repair, SAFETY ISSUE: In the attic, the chimney section showed deterioration - recommend having a chimney specialist inspect and evaluate for possible repairs.

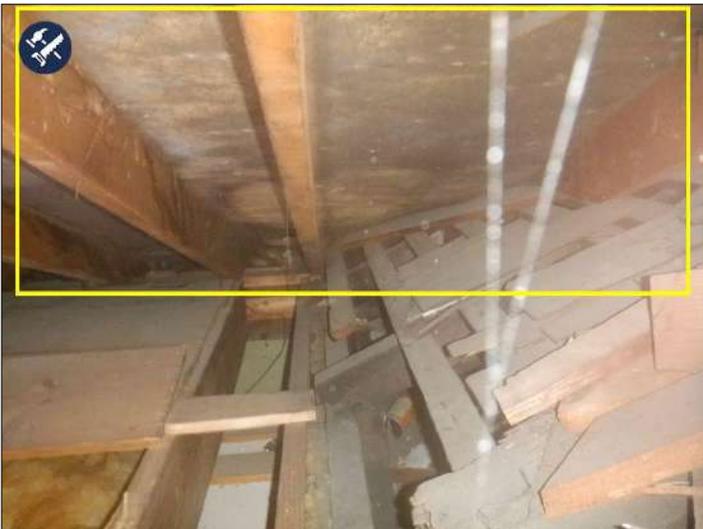
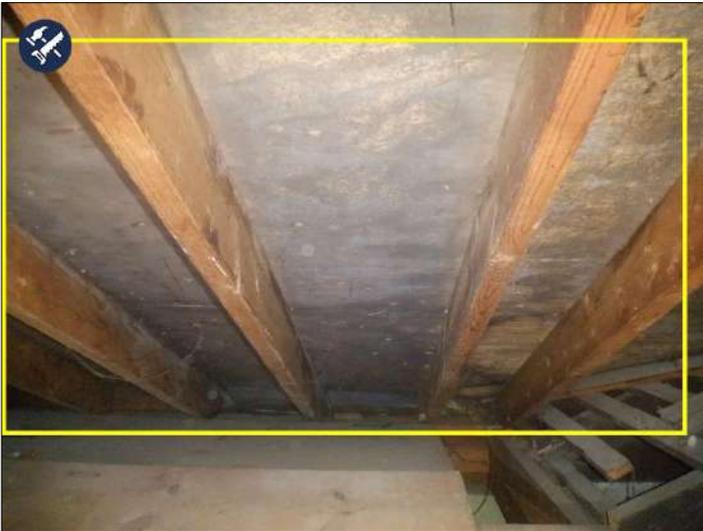
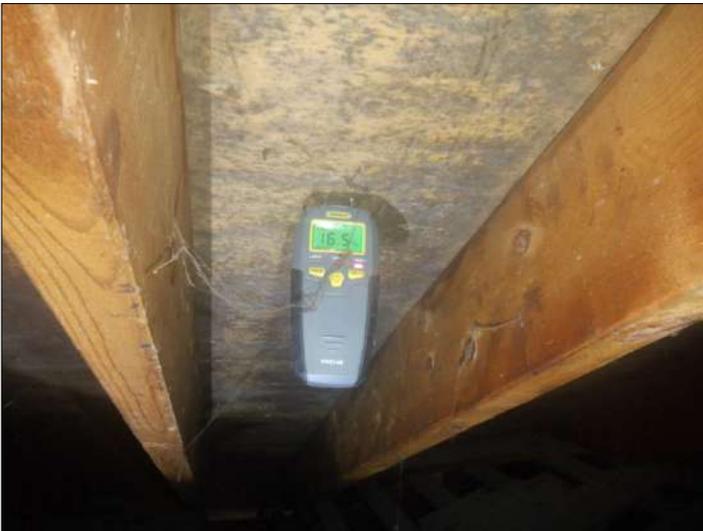
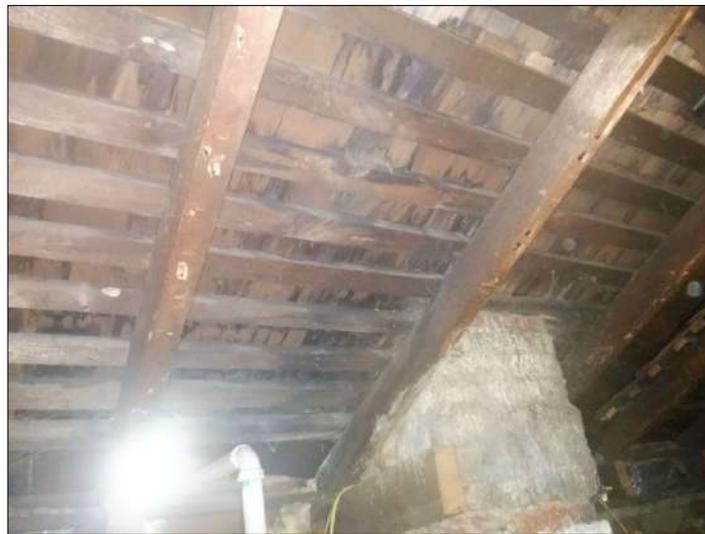
• Possible Concern: Throughout the rear of the attic, biogrowth was found on the roof sheathing and framing - recommend having a mold remediator inspect and evaluate the entire attic for possible repairs.

Possible Concern: Throughout the rear of the attic, biogrowth was found on the roof sheathing and framing - recommend having a mold remediator inspect and evaluate the entire attic for possible repairs.

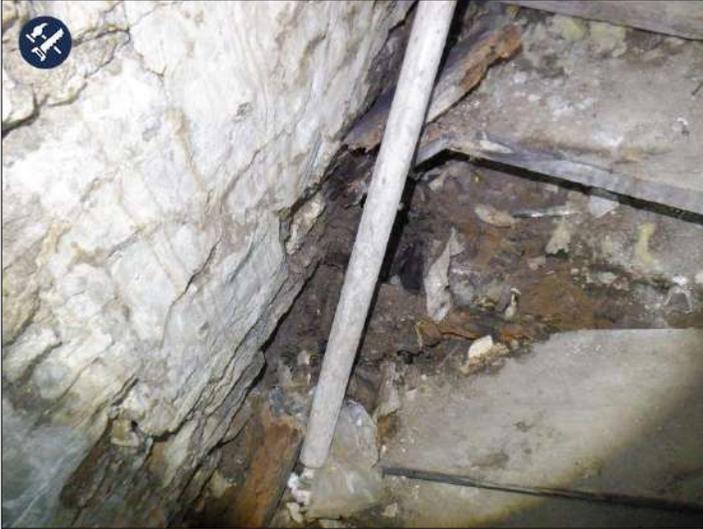
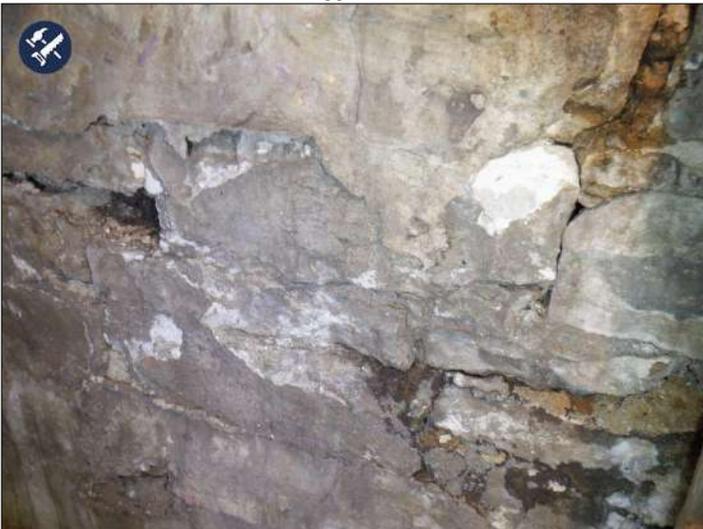
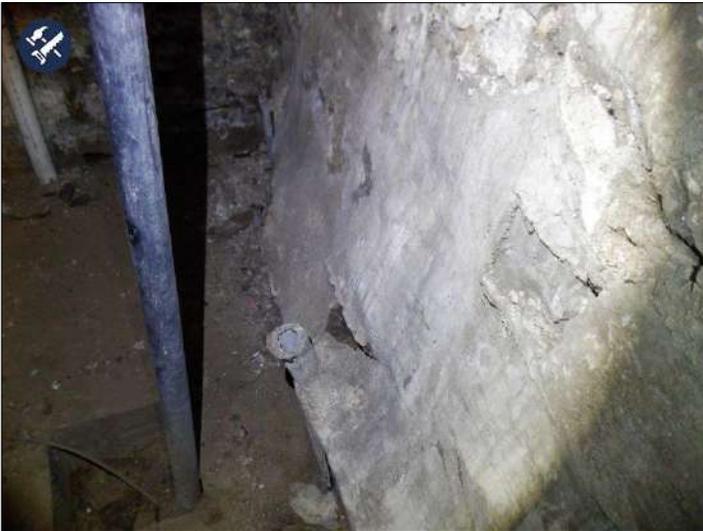
• Major Concern, Repair: The basement foundation walls have cracks, visible daylight, bowing and heaving and structural movement of the building appears to have occurred. Repairs are needed to protect the house from more serious damage. The rate of movement cannot be predicted during a one-time inspection. In addition, there was evidence of a significant ongoing moisture intrusion issue noted via water damaged wood, staining and streaking on the walls and the dirt floors. A structural engineer or a company specializing in foundation repairs should be consulted to evaluate the condition and suggest corrective measures.

Major Concern, Repair: The basement foundation walls have cracks, visible daylight, bowing and heaving and structural movement of the building appears to have occurred. Repairs are needed to protect the house from more serious damage. The rate of movement cannot be predicted during a one-time inspection. In addition, there was evidence of a significant ongoing moisture intrusion issue noted via water damaged wood, staining and streaking on the walls and the dirt floors. A structural engineer or a company specializing in foundation repairs should be consulted to evaluate the condition and suggest corrective measures.

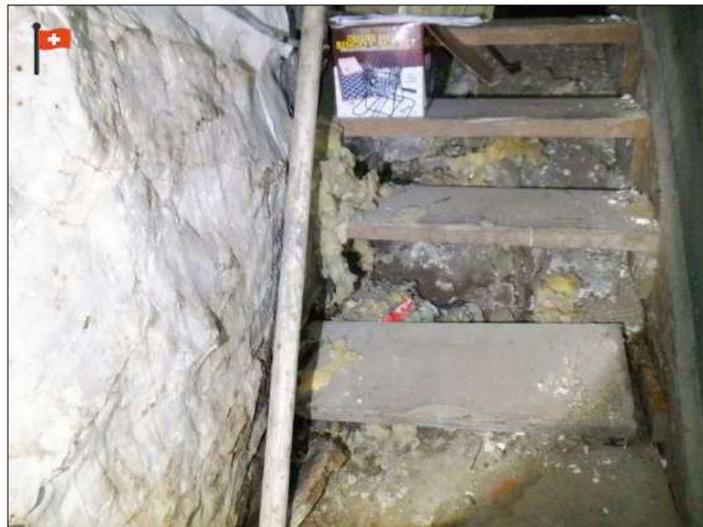
• Repair, SAFETY ISSUE: In the basement, the stairs are in very bad condition and in need of immediate repair/replacement - recommend repair for safety.

Repair, SAFETY ISSUE: In the basement, the stairs are in very bad condition and in need of immediate repair/replacement - recommend repair for safety.

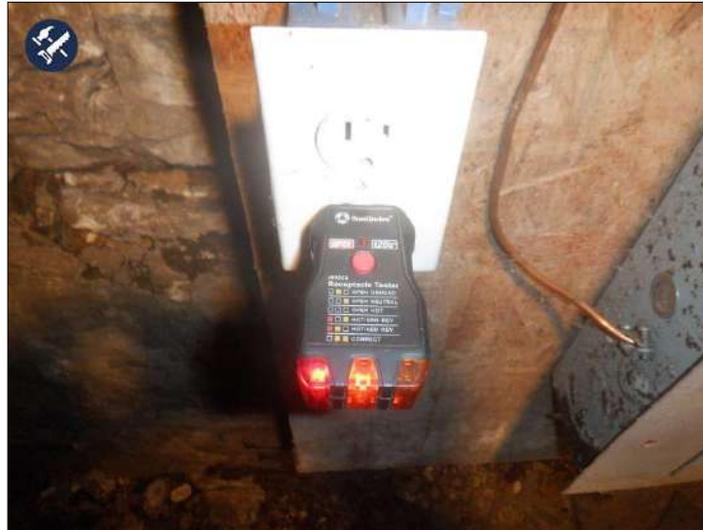
- Repair: The basement electrical outlet next to the electrical panel is wired with hot neutral reverse polarity - recommend having an electrical specialist inspect and evaluate for repairs.

Repair: The basement electrical outlet next to the electrical panel is wired with hot neutral reverse polarity - recommend having an electrical specialist inspect and evaluate for repairs.

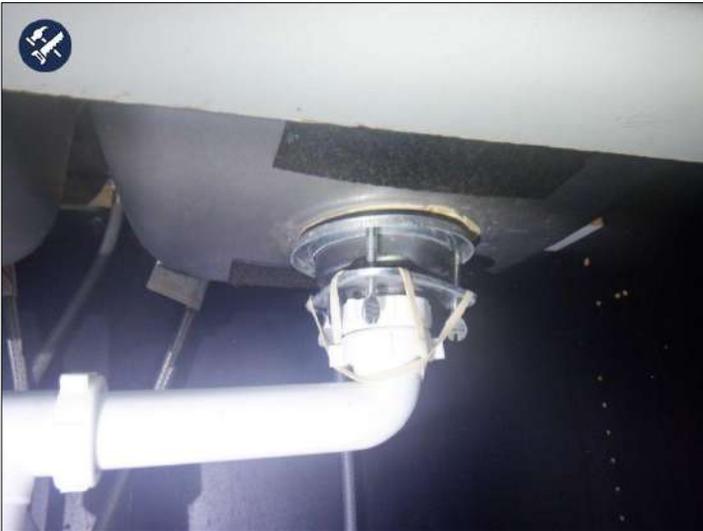
- Repair: The kitchen sink drain line leaks when in use – recommend having a plumbing specialist inspect and evaluate for possible repairs.

Repair: The kitchen sink drain line leaks when in use – recommend having a plumbing specialist inspect and evaluate for possible repairs.

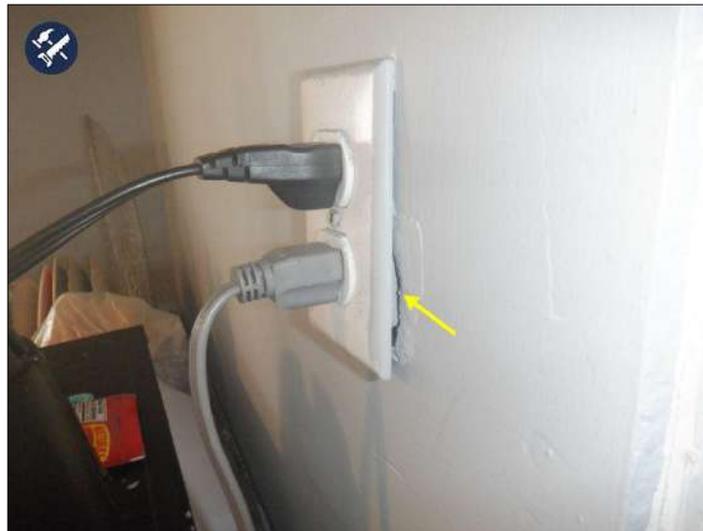
- Repair: The kitchen electrical outlet on the wall by the rear bedroom door electrical outlet is damaged - recommend having an electrical specialist inspect and evaluate for repairs.

Repair: The kitchen electrical outlet on the wall by the rear bedroom door electrical outlet is damaged - recommend having an electrical specialist inspect and evaluate for repairs.

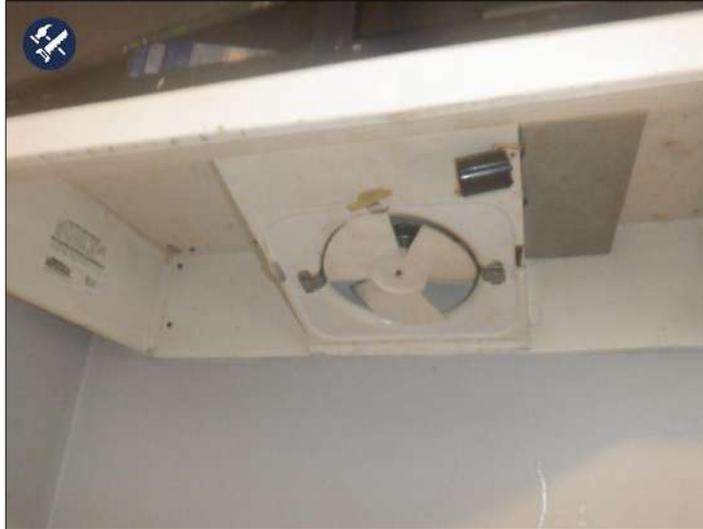
- Repair, SAFETY ISSUE: The stove does not have an anti-tip bracket installed - recommend repair for safety.
- Repair: The kitchen exhaust fan does not respond to the control switch and should be serviced or replaced - recommend repair.

Repair: The kitchen exhaust fan does not respond to the control switch and should be serviced or replaced - recommend repair.

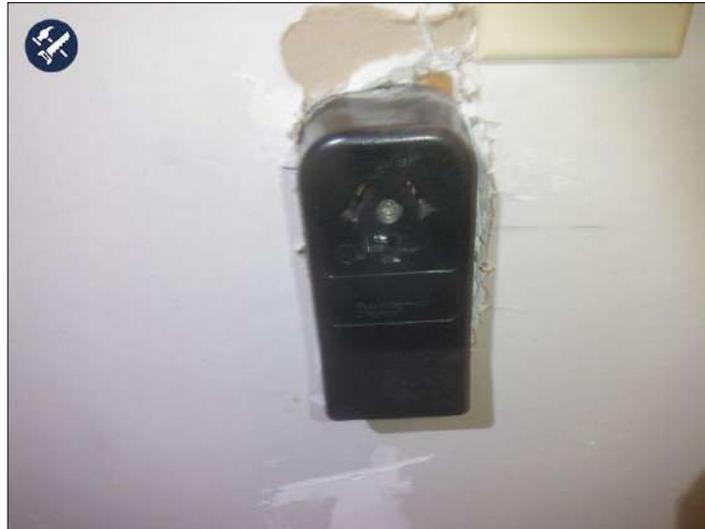
• Repair: The wiring leading to the clothes dryer is a 3 prong type receptacle. Newer units have 4 prong receptacles. This may need to be upgraded to a newer type when changing dryers. Many homes may have circumstances where construction practices or standards have changed since the home was built. Updating/upgrading systems are not a requirement if the home was built to the standards of the day construction was completed. It would be cost prohibitive to bring everything to current standards for every home.

Repair: The wiring leading to the clothes dryer is a 3 prong type receptacle. Newer units have 4 prong receptacles. This may need to be upgraded to a newer type when changing dryers. Many homes may have circumstances where construction practices or standards have changed since the home was built. Updating/upgrading systems are not a requirement if the home was built to the standards of the day construction was completed. It would be cost prohibitive to bring everything to current standards for every home.

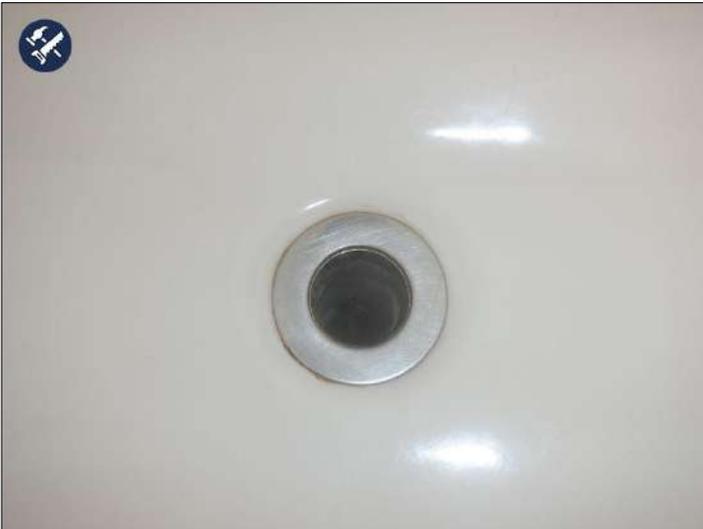
- Repair: The sink drain stopper is missing hardware – recommend having a plumbing specialist inspect and evaluate for possible repairs.

Repair: The sink drain stopper is missing hardware – recommend having a plumbing specialist inspect and evaluate for possible repairs.

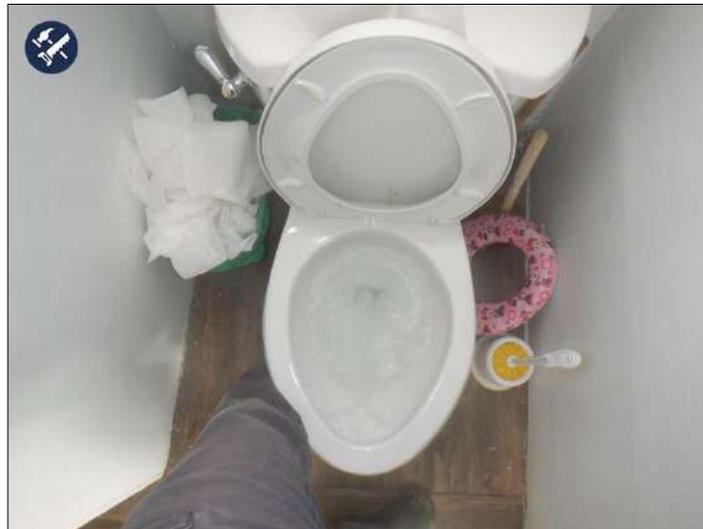
- Repair: The bathroom toilet bowl is loose - recommend replacing the wax ring seal and checking for subflooring damage before tightening the unit down – recommend having a plumbing specialist inspect and evaluate for possible repairs.

Repair: The bathroom toilet bowl is loose - recommend replacing the wax ring seal and checking for subflooring damage before tightening the unit down – recommend having a plumbing specialist inspect and evaluate for possible repairs.

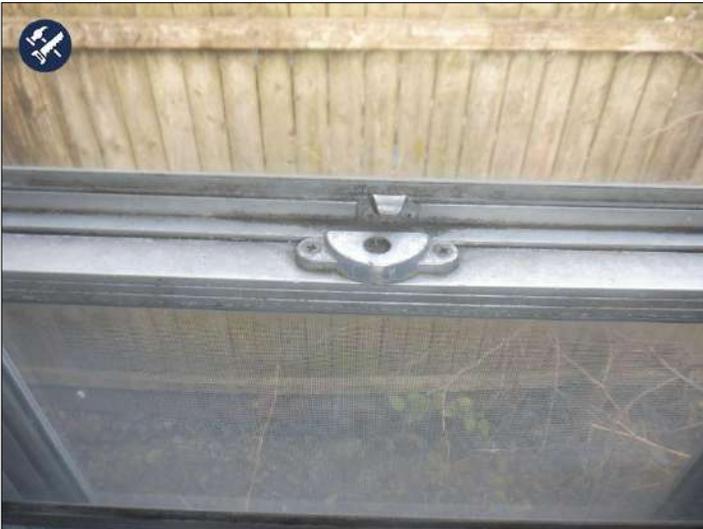
- Repair: The window above the toilet has damaged hardware (locks, cranks, or handles), and a broken counter balance - recommend having a window specialist inspect and evaluate for repairs/replacement.

Repair: The window above the toilet has damaged hardware (locks, cranks, or handles), and a broken counter balance - recommend having a window specialist inspect and evaluate for repairs/replacement.

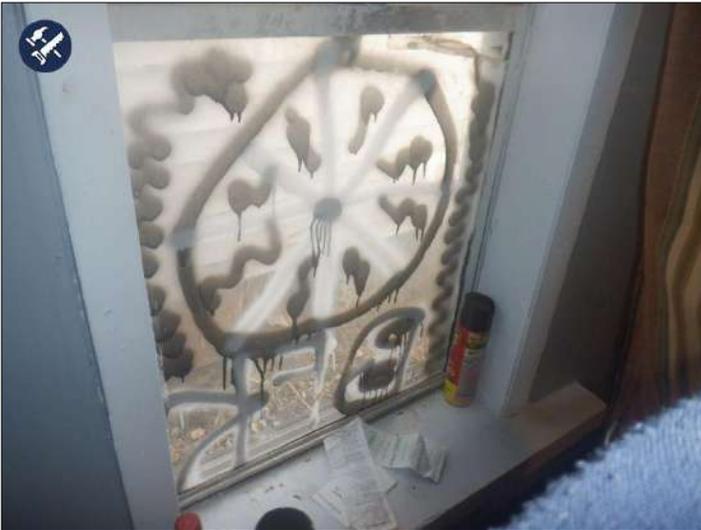
- Repair: The window has cracked glass and has been spray painted - recommend having a window specialist inspect and evaluate for repairs/replacement.

Repair: The window has cracked glass and has been spray painted - recommend having a window specialist inspect and evaluate for repairs/replacement.

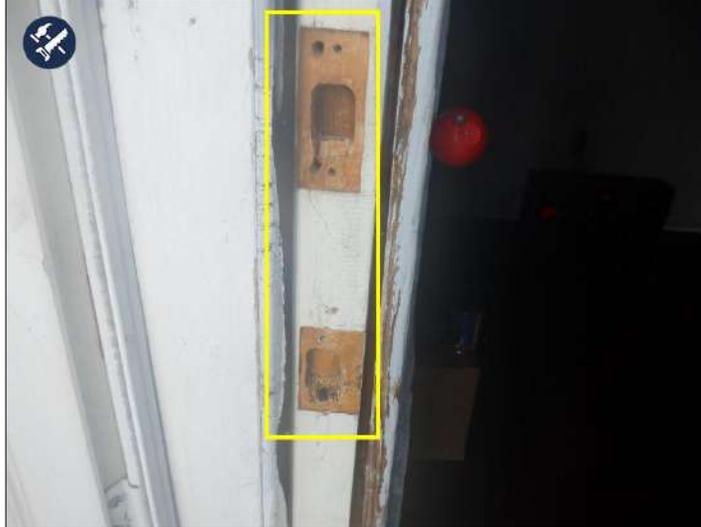
- Repair: The front entry door is missing the striker plates for the door handle and deadbolt – recommend repair.

Repair: The front entry door is missing the striker plates for the door handle and deadbolt – recommend repair.

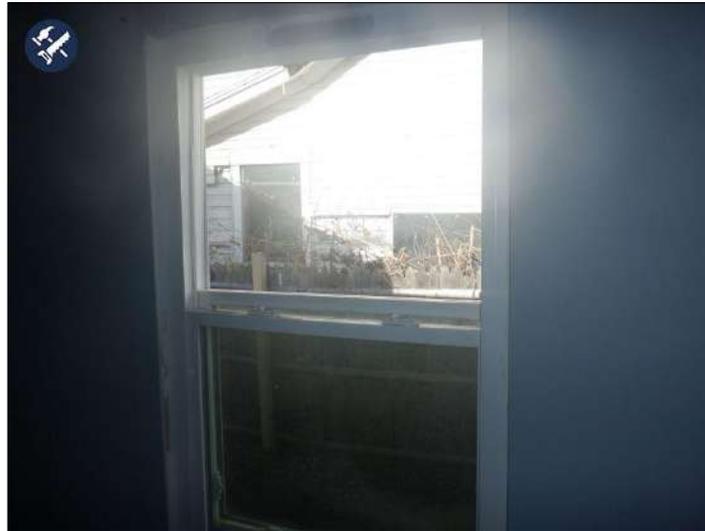
- Repair: The upper pane of the side wall window has a broken counterbalance - recommend having a window specialist inspect and evaluate for repairs/replacement.

Repair: The upper pane of the side wall window has a broken counterbalance - recommend having a window specialist inspect and evaluate for repairs/replacement.

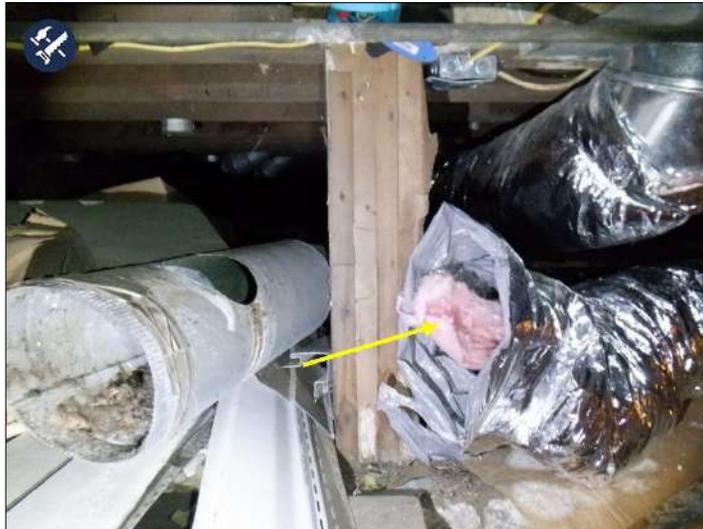
- **Repair:** The HVAC ductwork in the basement is not connected - recommend having a licensed HVAC specialist inspect and evaluate for repairs.

Repair: The HVAC ductwork in the basement is not connected - recommend having a licensed HVAC specialist inspect and evaluate for repairs.

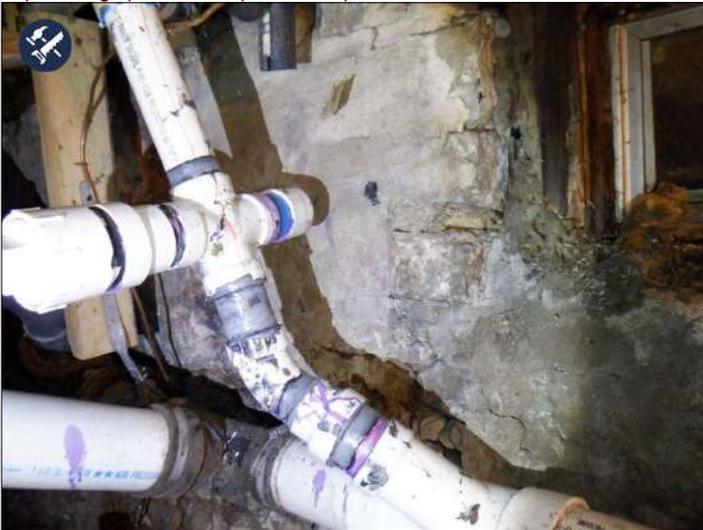
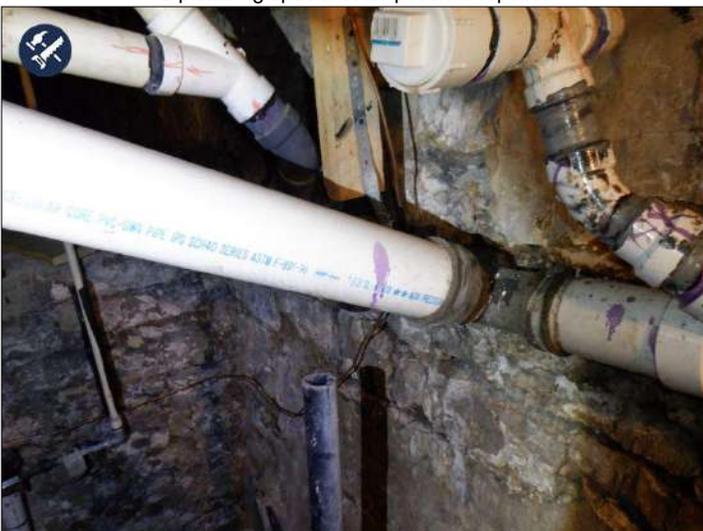
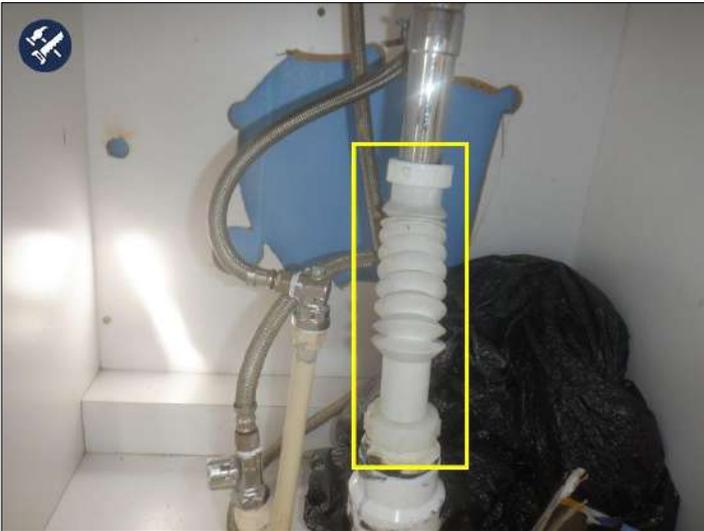
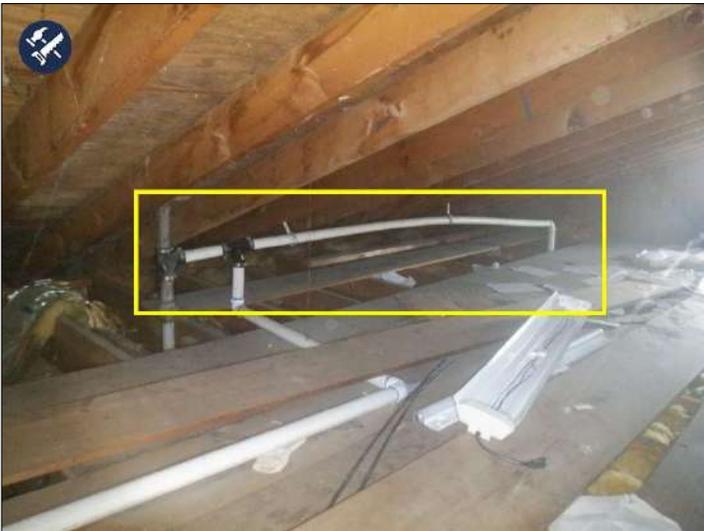
• Possible, Concern, Repair: The plumbing fixtures, drain lines and vents were observed as improperly and unprofessionally installed throughout the home. Improper connections were noted in the basement, missing vent covers and caps were observed in the laundry room, improper drains/traps were observed under the sinks and the plumbing ventilation in the attic was not connected near the access panel and was not professionally installed in the rear of the attic. The inspection HIGHLY recommends the incoming, outgoing and plumbing vents lines all be inspected and evaluated further by a plumbing specialist for possible repairs.

Possible, Concern, Repair: The plumbing fixtures, drain lines and vents were observed as improperly and unprofessionally installed throughout the home. Improper connections were noted in the basement, missing vent covers and caps were observed in the laundry room, improper drains/traps were observed under the sinks and the plumbing ventilation in the attic was not connected near the access panel and was not professionally installed in the rear of the attic. The inspection HIGHLY recommends the incoming, outgoing and plumbing vents lines all be inspected and evaluated further by a plumbing specialist for possible repairs.
