PROPERTY INSPECTION REPORT

Tony Burk
OHI.2019004151 expr. 8/1/2022
Accutech Home Inspections

123 Main St
Inspection Prepared For: Owner Homer
Agent:

Date of Inspection: 3/12/21
Age of House: 1895 Size: 1148
Weather: Overcast

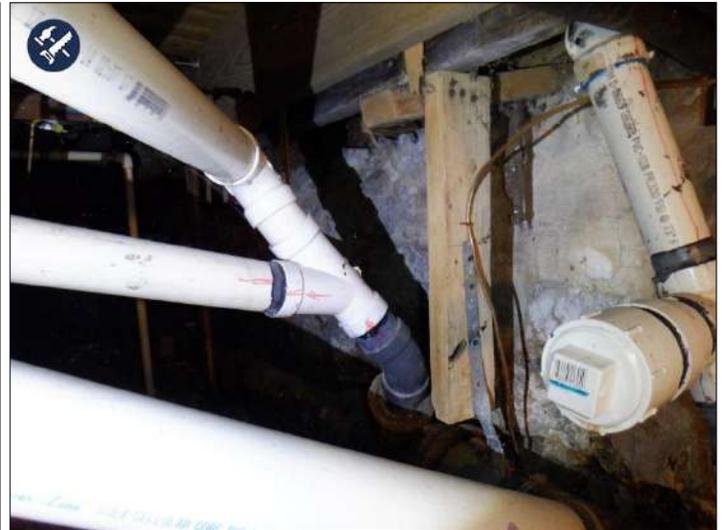
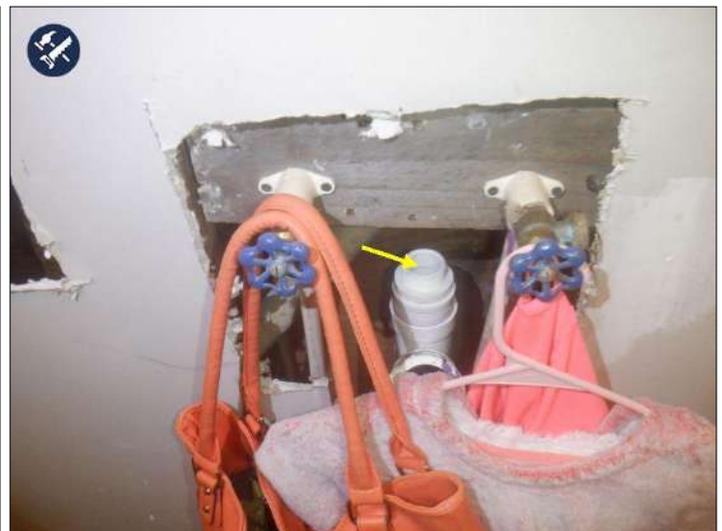
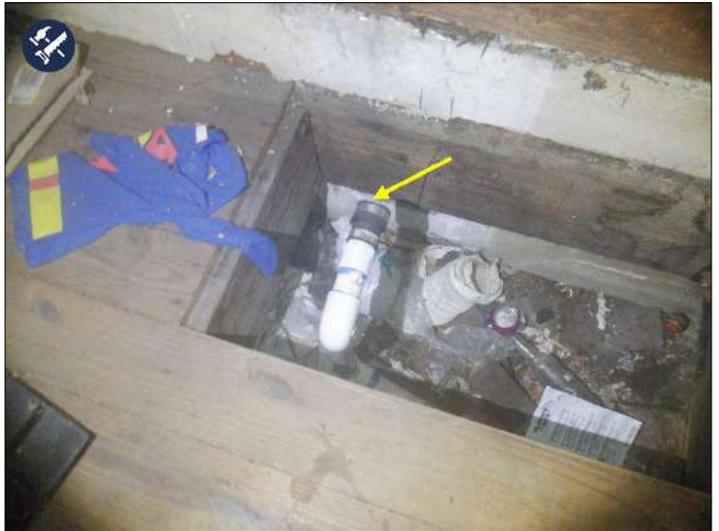
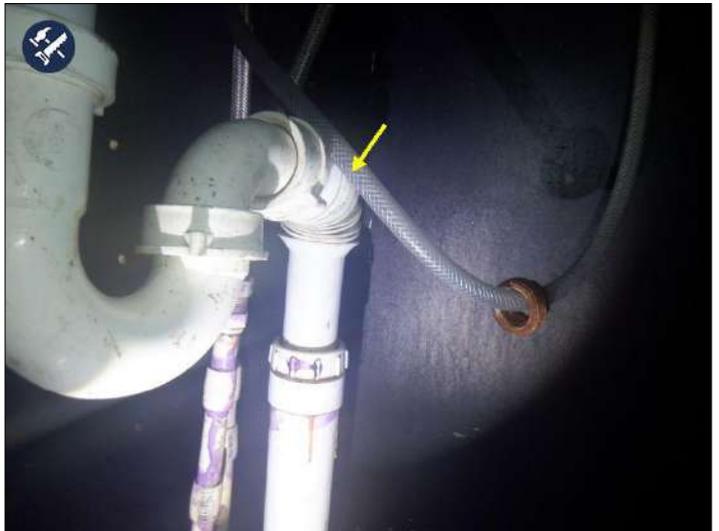
Possible, Concern, Repair: The plumbing fixtures, drain lines and vents were observed as improperly and unprofessionally installed throughout the home. Improper connections were noted in the basement, missing vent covers and caps were observed in the laundry room, improper drains/traps were observed under the sinks and the plumbing ventilation in the attic was not connected near the access panel and was not professionally installed in the rear of the attic. The inspection HIGHLY recommends the incoming, outgoing and plumbing vents lines all be inspected and evaluated further by a plumbing specialist for possible repairs.

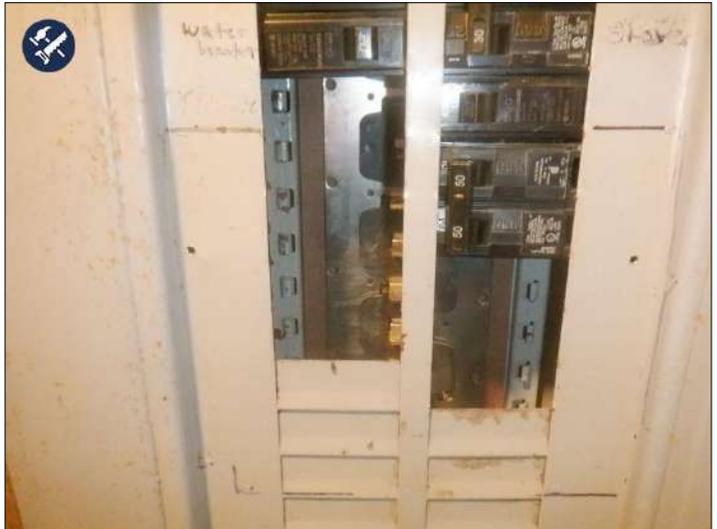
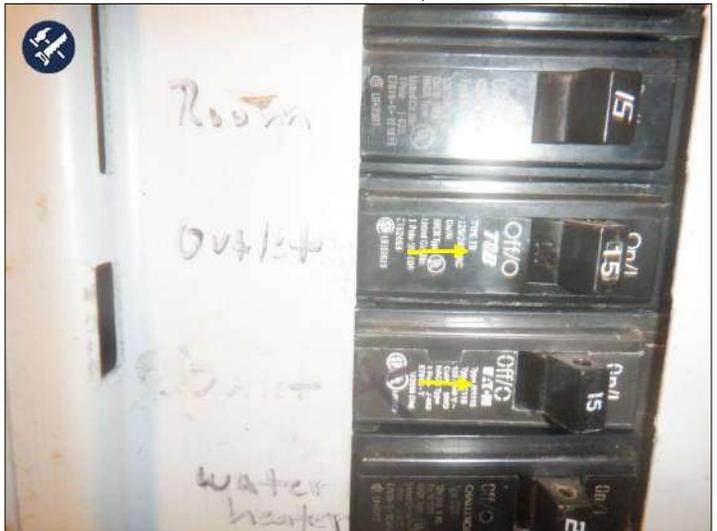
Repair: The electrical panel has open "knockouts". In addition, there were breakers from multiple manufacturers noted in the panel. It is **HIGHLY** suggested that the breakers in the panels all are from the same manufacturer - recommend having a licensed electrical specialist inspect and evaluate for repairs.

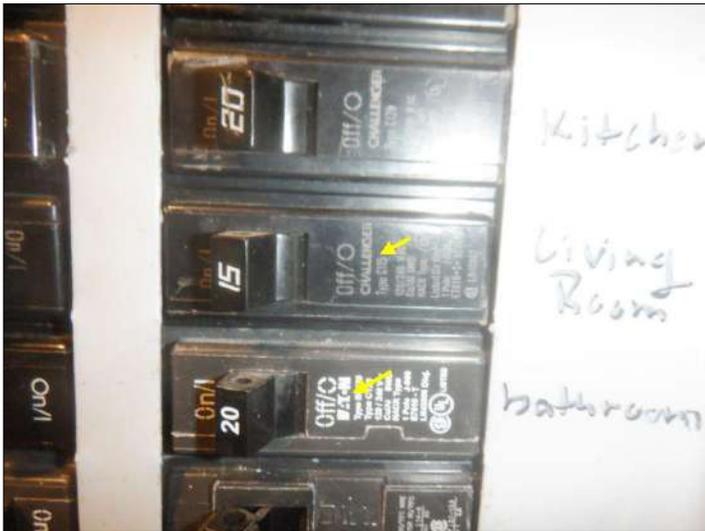
• Repair: The electrical panel has open "knockouts". In addition, there were breakers from multiple manufacturers noted in the panel. It is HIGHLY suggested that the breakers in the panels all are from the same manufacturer - recommend having a licensed electrical specialist inspect and evaluate for repairs.
